Hazardous Building Materials (HBM) Survey

Proposed Residential Development  
147, 151 and 153 Kurraba Road  
Kurraba Point NSW

Prepared for  
Thirdi Group

Project 86447.06  
August 2020

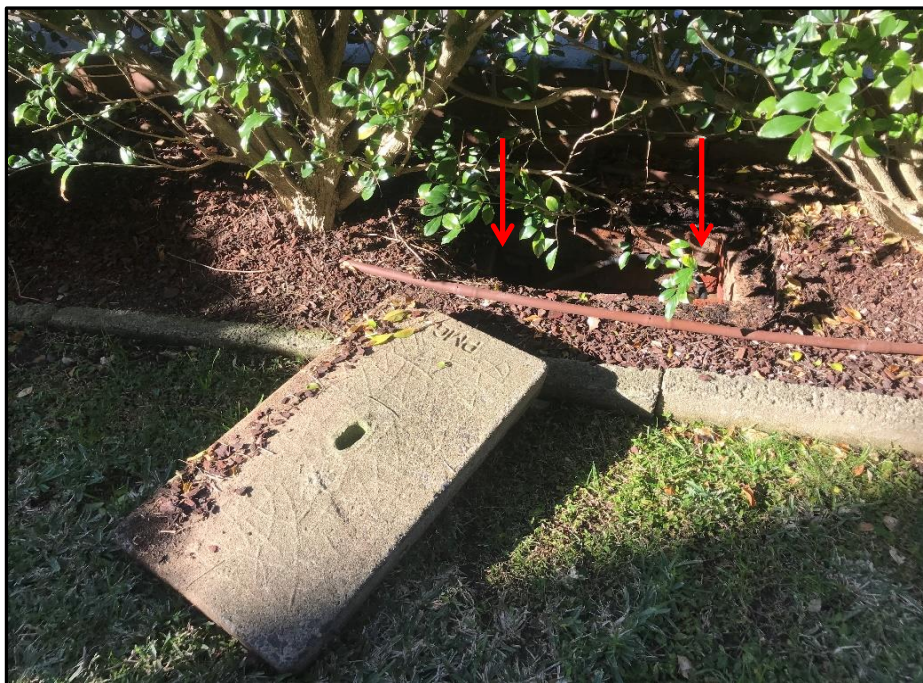
Photograph 3: 147 Kurraba Road, South Block, exterior, southern garden bed, PMG pit, fibre cement product, asbestos detected by analysis.

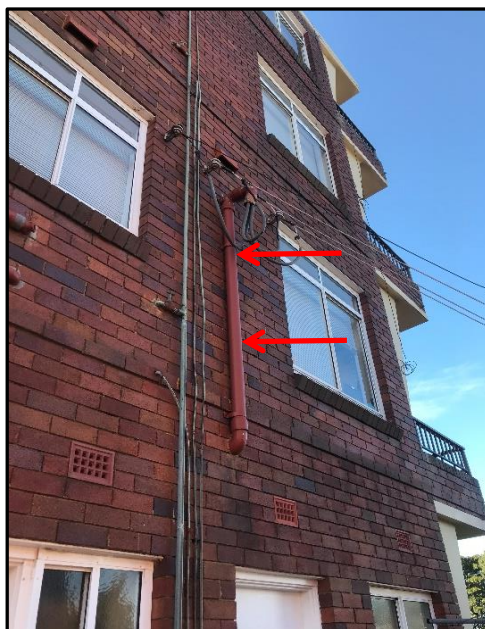
Photograph 4: 147 Kurraba Road, South Block, exterior western façade, electrical conduit (pipe), fibre cement product, asbestos detected by analysis.

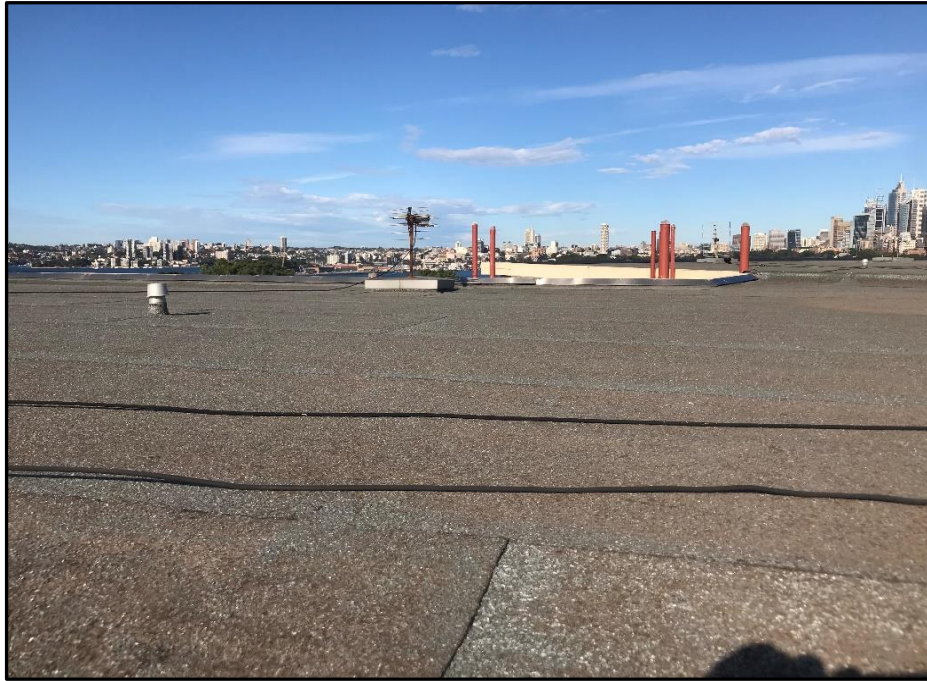
Photograph 5: 147 Kurraba Road, North Block, roof, surface of roof generally, textured waterproofing membrane and underlying bitumastic, no asbestos detected by analysis. SMF detected by analysis..

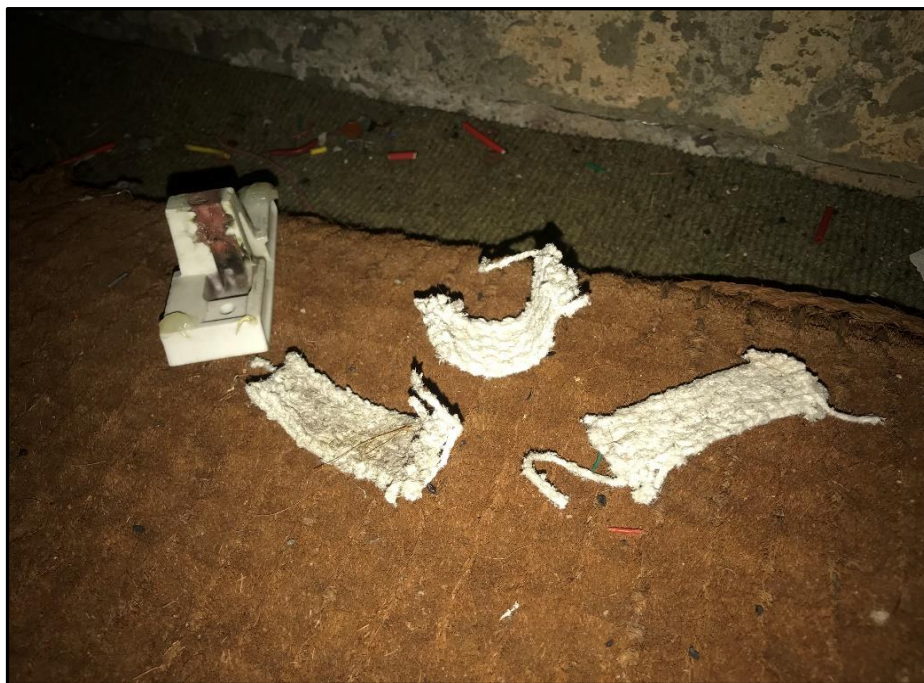
Photograph 6: 147 Kurraba Road, North Block, interior, base of front stairwell, electrical room, loose fuse insulation, asbestos detected by analysis.

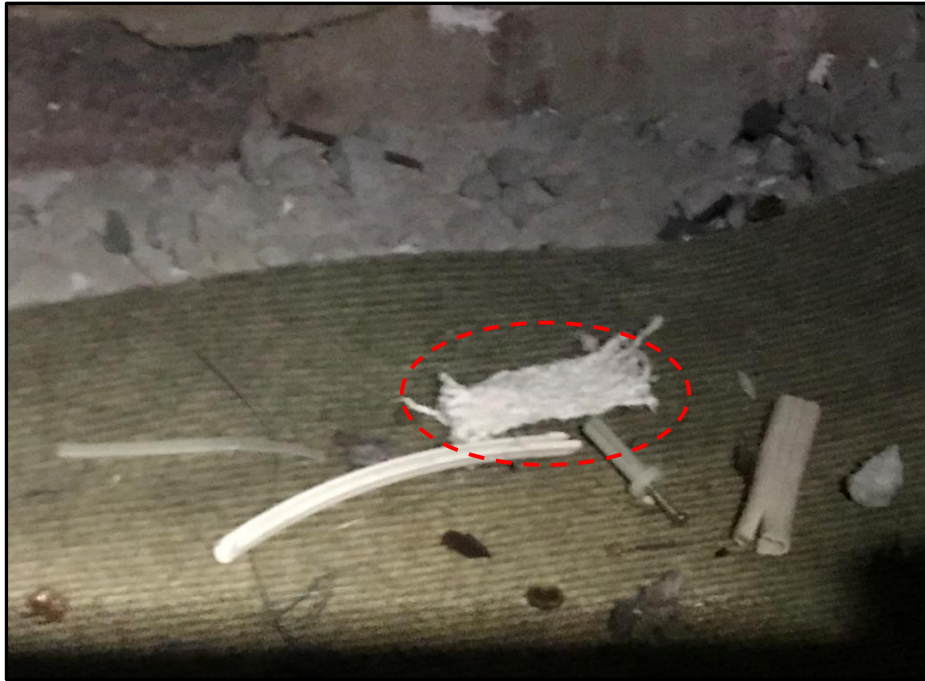
Photograph 7: 147 Kurraba Road, North Block, interior, base of front stairwell, electrical room, loose fuse insulation, asbestos detected by analysis.

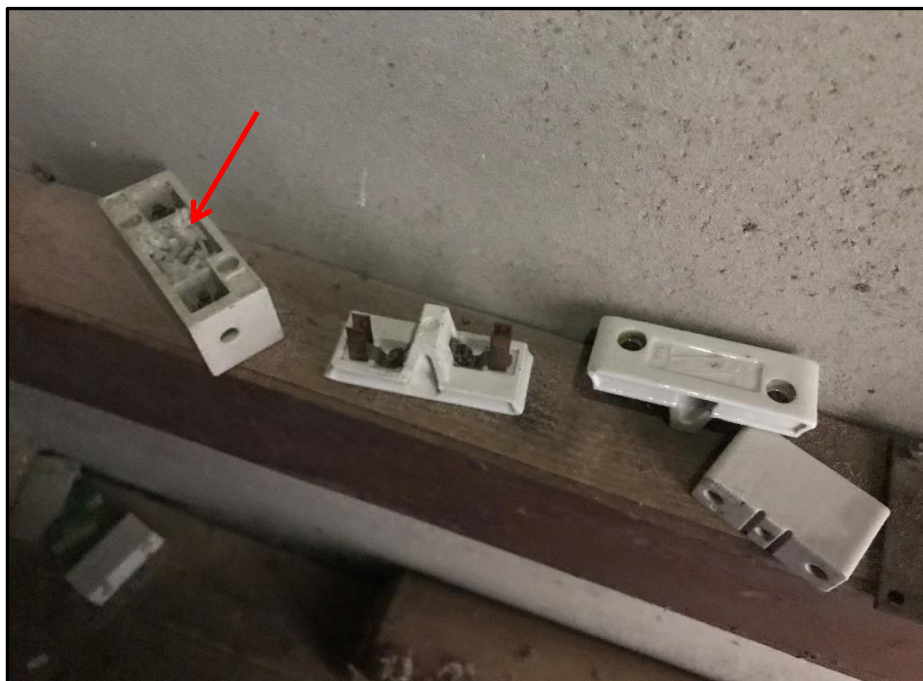
Photograph 8: 147 Kurraba Road, South Block, interior, base of front stairwell, electrical room, loose and bagged fuse insulation, asbestos identified visually.

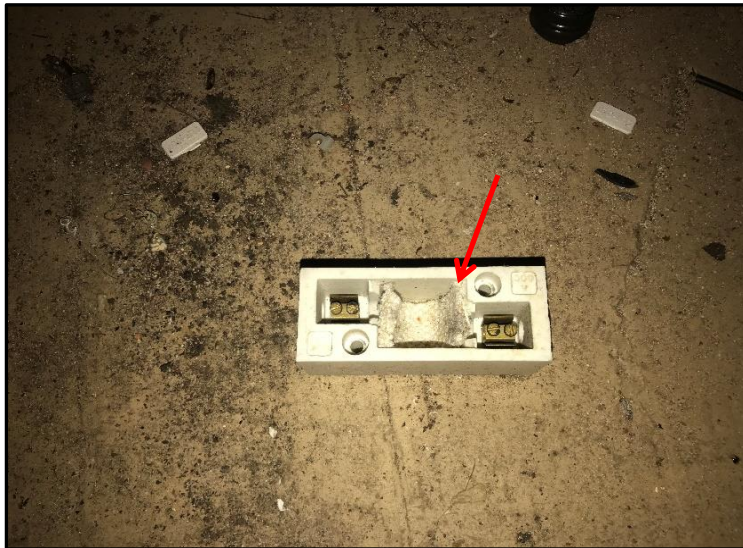
Photograph 9: 147 Kurraba Road, South Block, interior, base of front stairwell, electrical room, loose and bagged fuse insulation, asbestos identified visually.

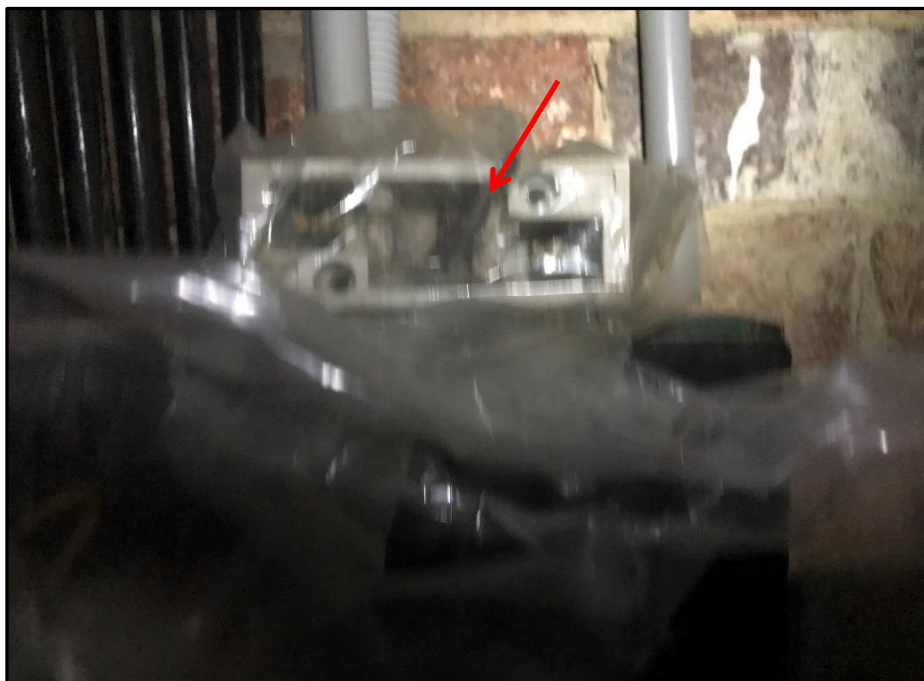
Photograph 10: 147 Kurraba Road, South Block, interior, base of front stairwell, electrical room, loose and bagged fuse insulation, asbestos identified visually.

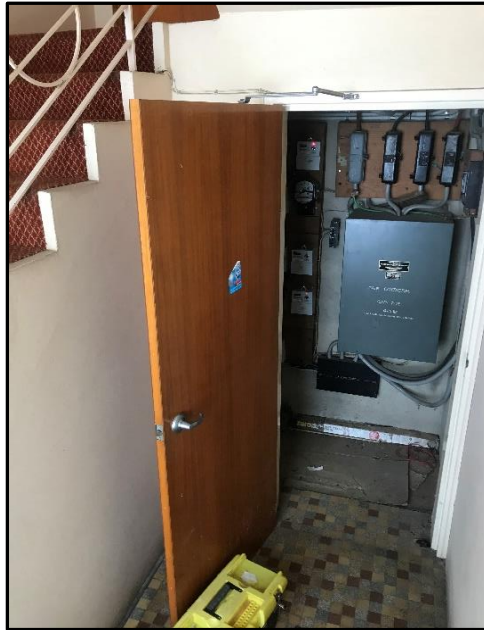
Photograph 11: 147 Kurraba Road, South Block, interior, base of front stairwell, electrical room, fire door, outer core insulation (exposed surface), suspected non-asbestos.

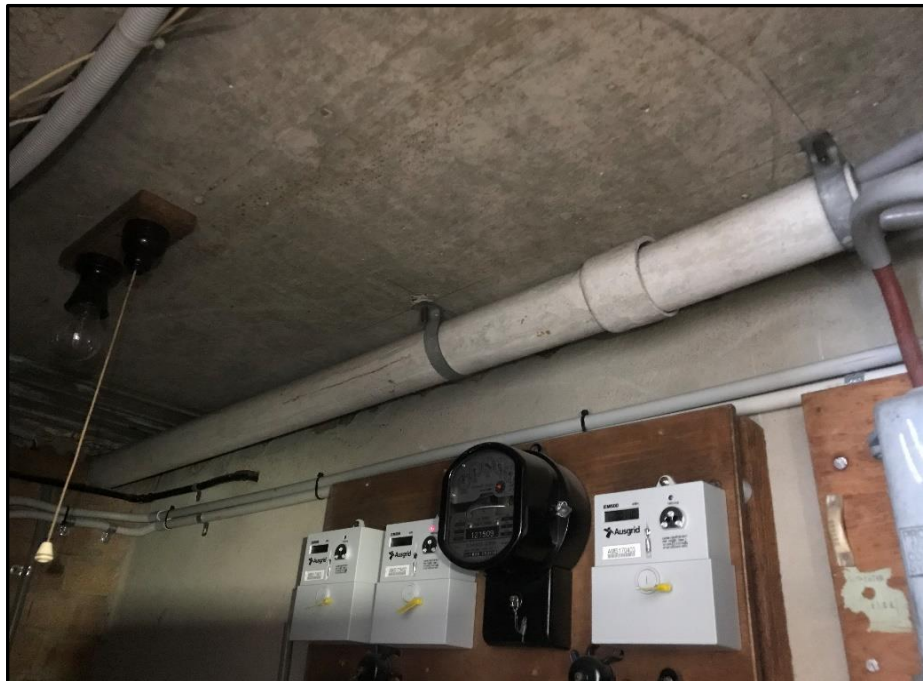
Photograph 12: 147 Kurraba Road, South Block, interior, base of front stairwell, electrical room, service duct (pipe), fibre cement pipe, asbestos assumed.

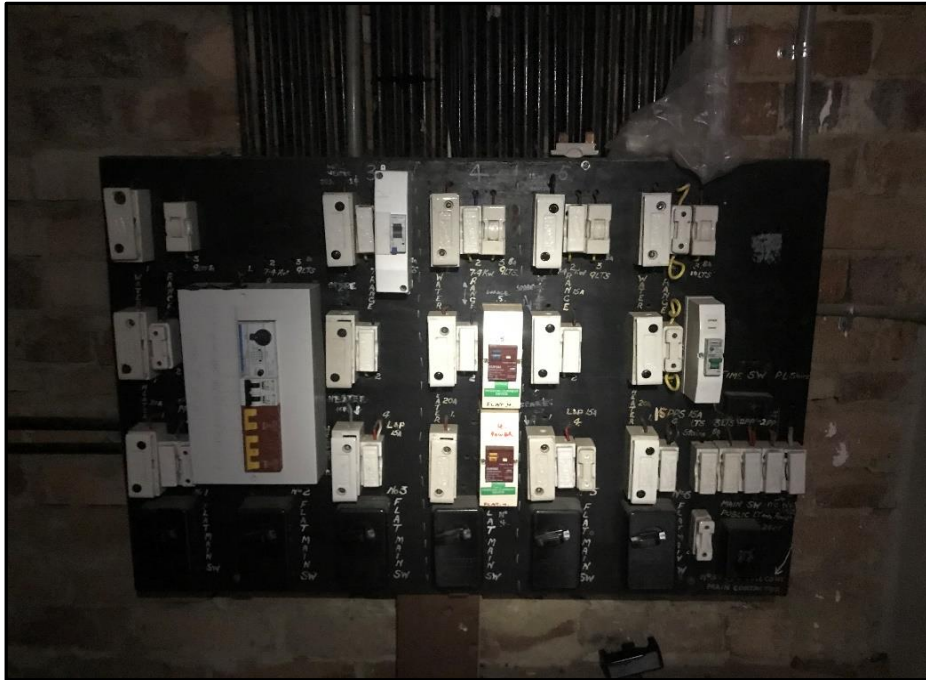
Photograph 13: 147 Kurraba Road, South Block, interior, base of front stairwell, electrical room, main electrical board, resinous board, asbestos assumed.

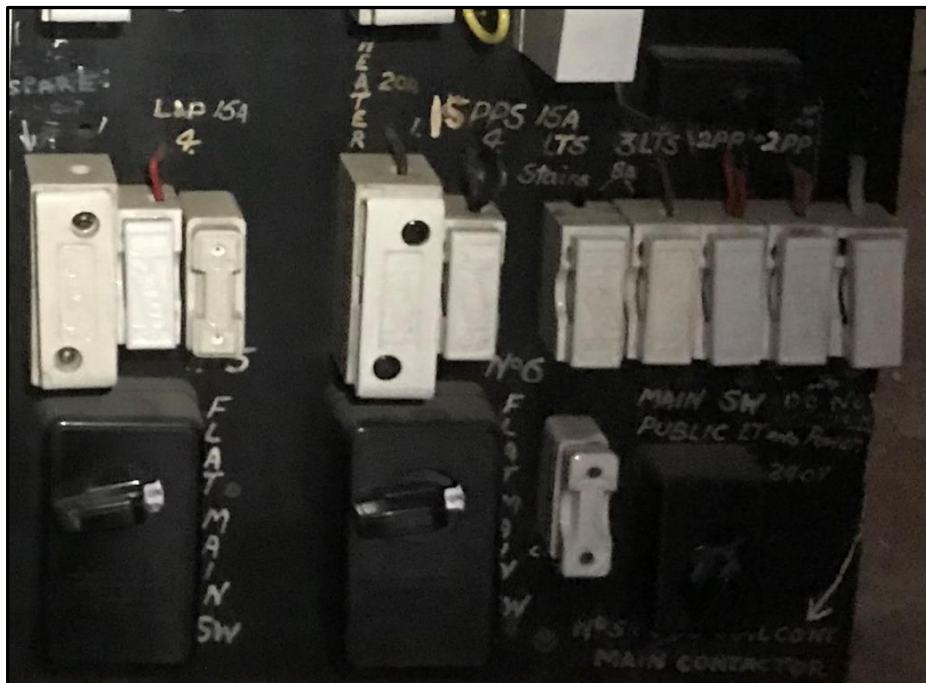
Photograph 14: 147 Kurraba Road, South Block, interior, base of front stairwell, electrical room, fuses generally, internal insulation, asbestos assumed.

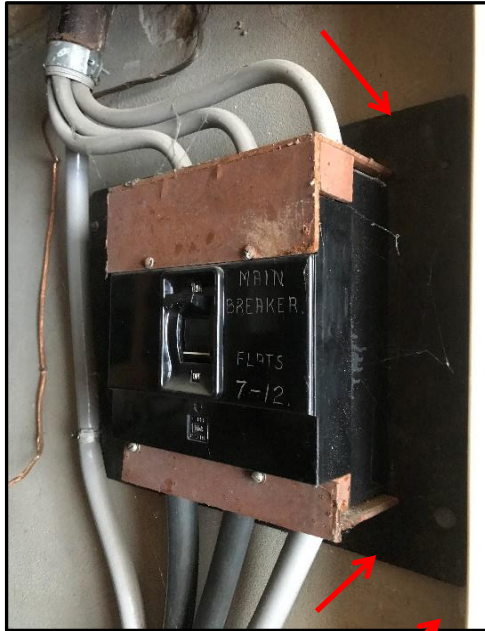
Photograph 15: 147 Kurraba Road, South Block, interior, base of front stairwell, main breaker, electrical board, resinous board, asbestos assumed.

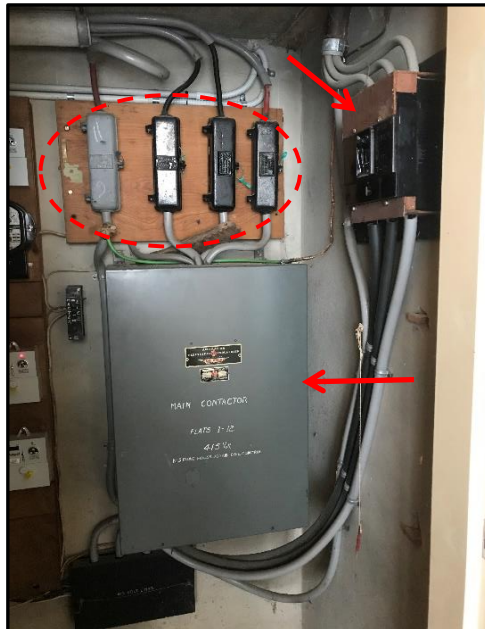
Photograph 16: 147 Kurraba Road, South Block, interior, base of front stairwell, enclosed panels and equipment generally (e.g. Main Contactor 415V, 415 Volt Links, Main Breaker), internal components, may contain asbestos.

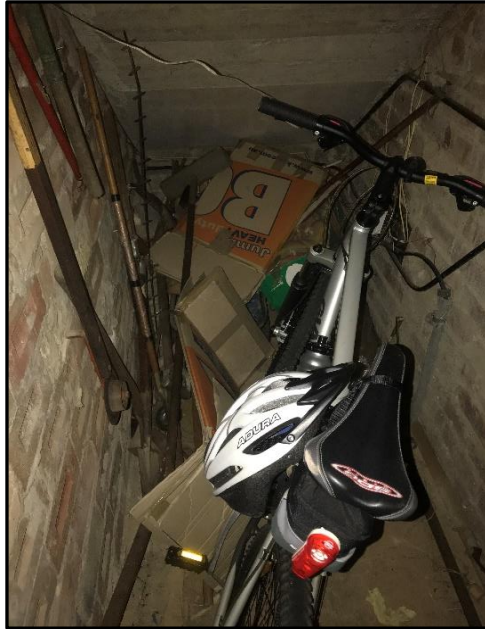
Photograph 17: 147 Kurraba Road, South Block, interior, base of front stairwell, electrical room, materials in general, limited access.

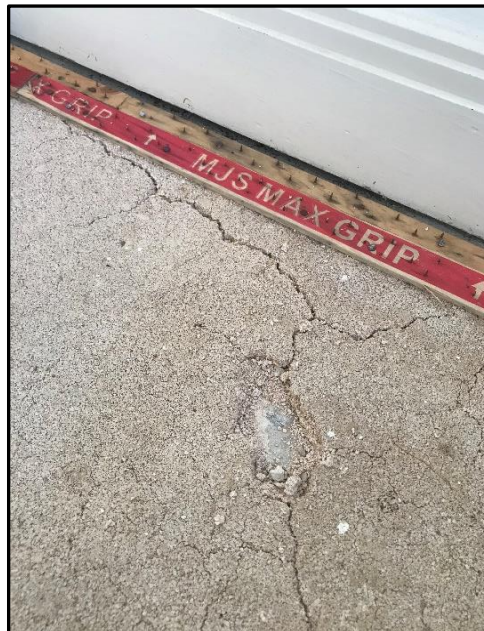
Photograph 18: 147 Kurraba Road, Unit 12, interior, entrance and living areas, floor below carpet, slab topping, no asbestos detected by analysis.

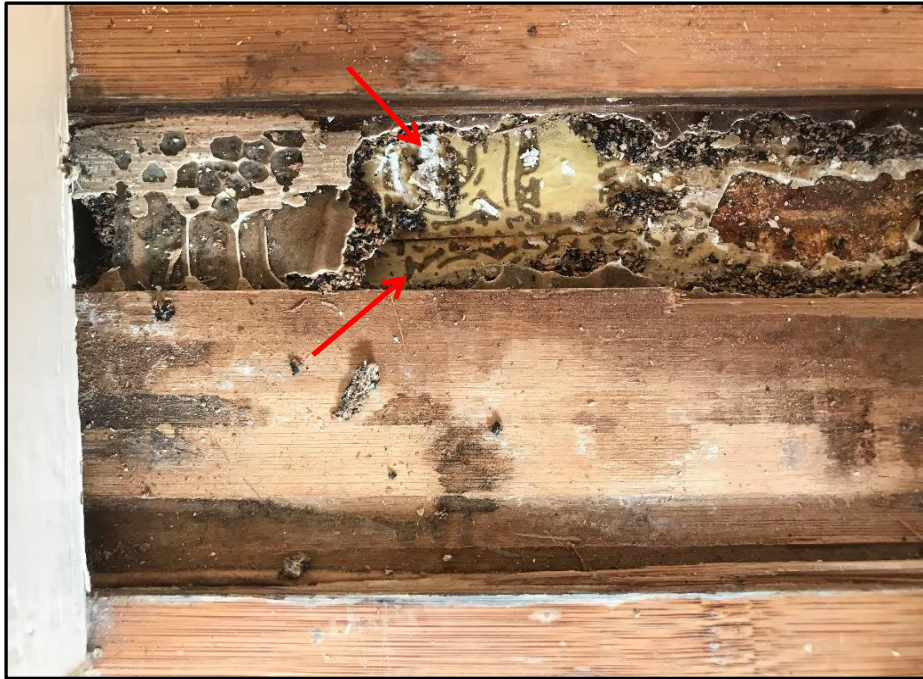
Photograph 19: 147 Kurraba Road, Unit 12, interior, kitchen floor (below floorboards and bitumastic layer), vinyl flooring, no asbestos detected by analysis.

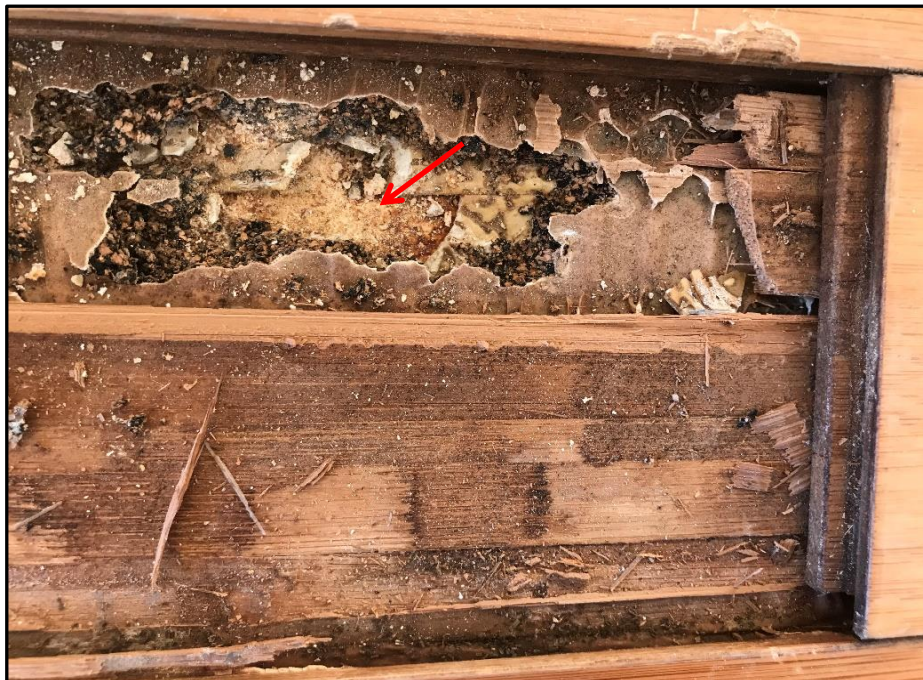
Photograph 20: 147 Kurraba Road, Unit 12, interior, kitchen floor (below vinyl flooring), slab topping, no asbestos detected by analysis.

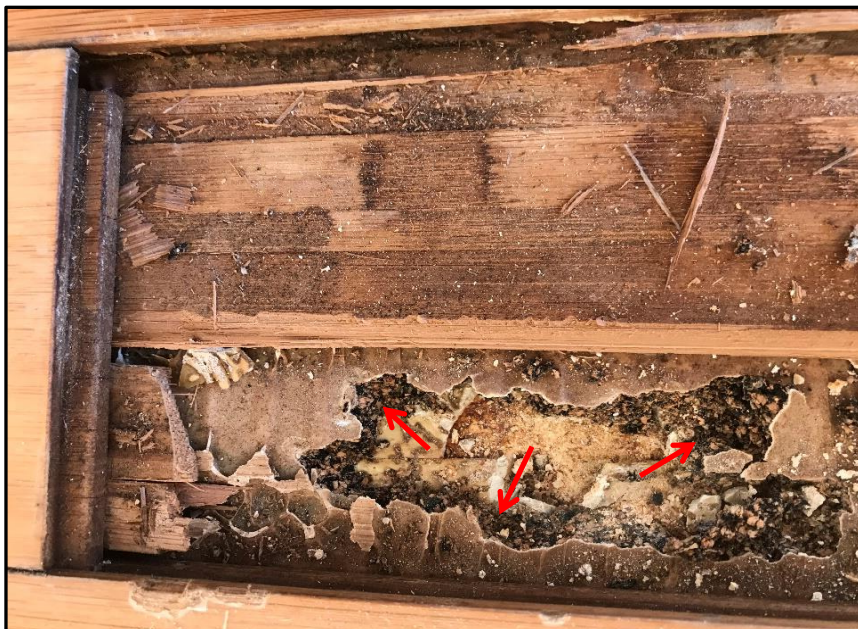
Photograph 21: 147 Kurraba Road, Unit 12, interior, kitchen floor (below floorboards), bituminous layer containing cork (or similar) and surficial adhesives, no asbestos detected by analysis.

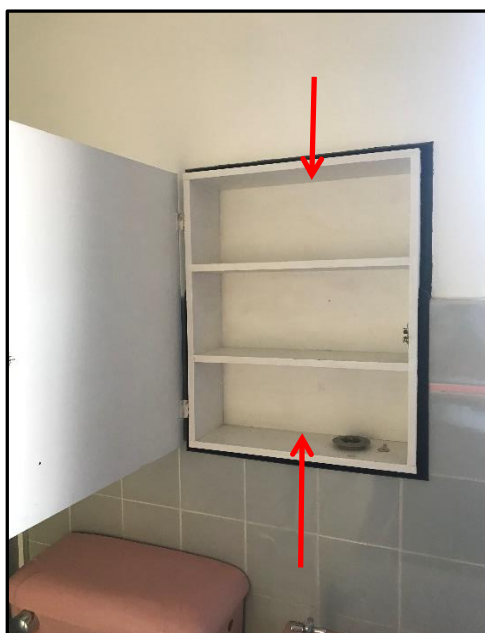
Photograph 22: 147 Kurraba Road, Unit 6, interior, bathroom, wall lining to mirror cabinet, fibre cement, asbestos detected by analysis.

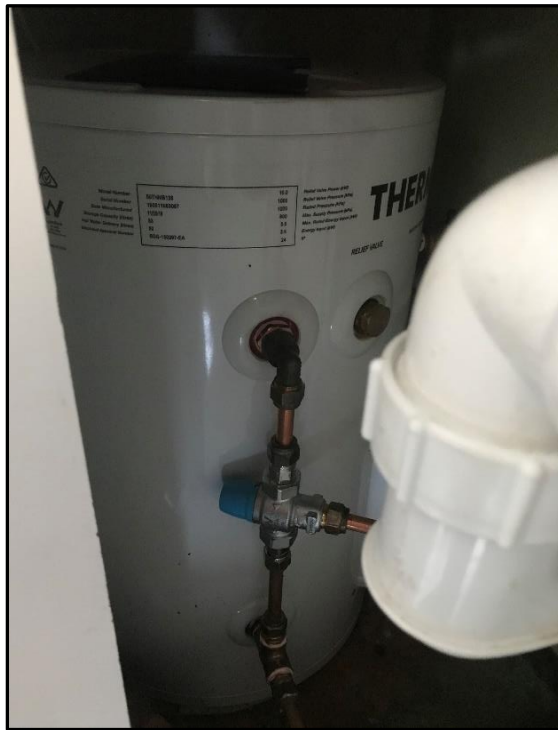
Photograph 23: 147 Kurraba Road, Unit 6, interior, kitchen, hot water unit (circa 2019), bulk insulation, suspected SMF or foam.

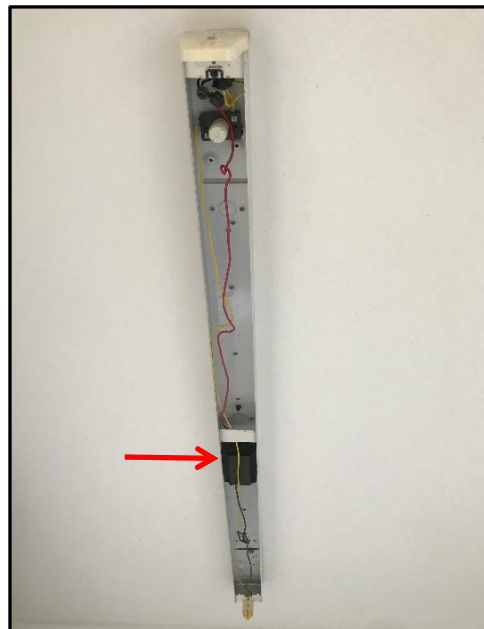
Photograph 24: 147 Kurraba Road, Unit 6, interior, kitchen, ceiling, fluorescent light fitting, internal component (ballast), PCB (assumed).

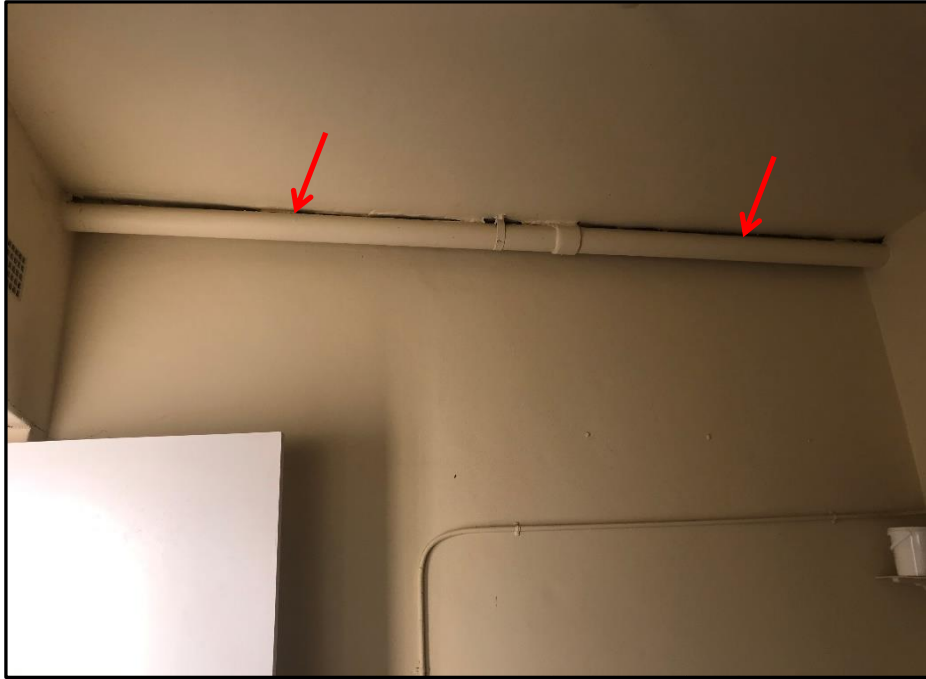
Photograph 25: 147 Kurraba Road, South Block, interior, communal laundry, service conduit, fibre cement pipe, asbestos assumed.

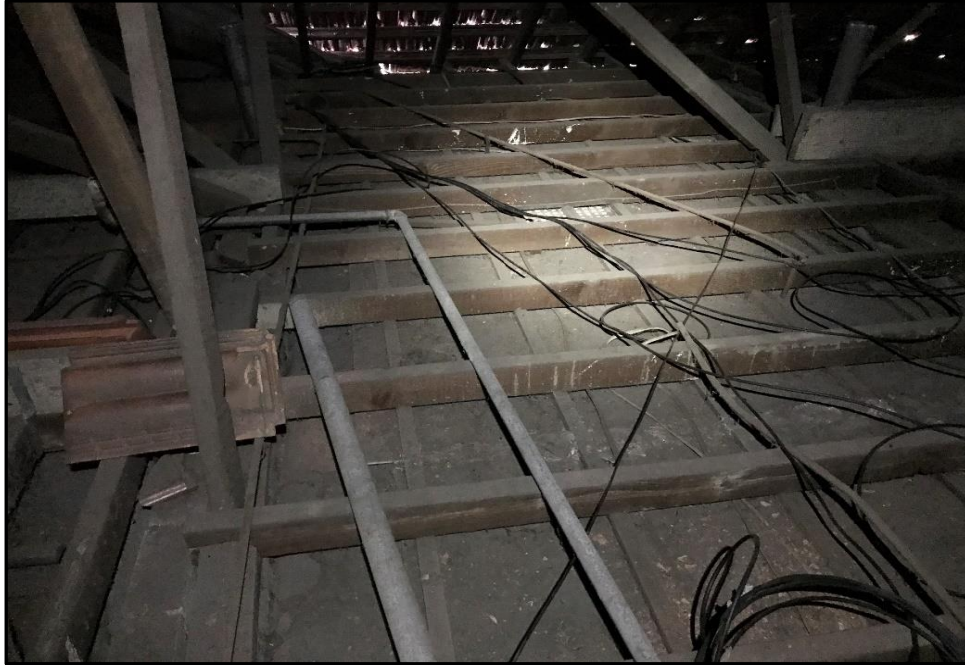
Photograph 1: 151 Kurraba Road, roof cavity, throughout, settled dust, elevated lead concentration detected (340 mg/m2).

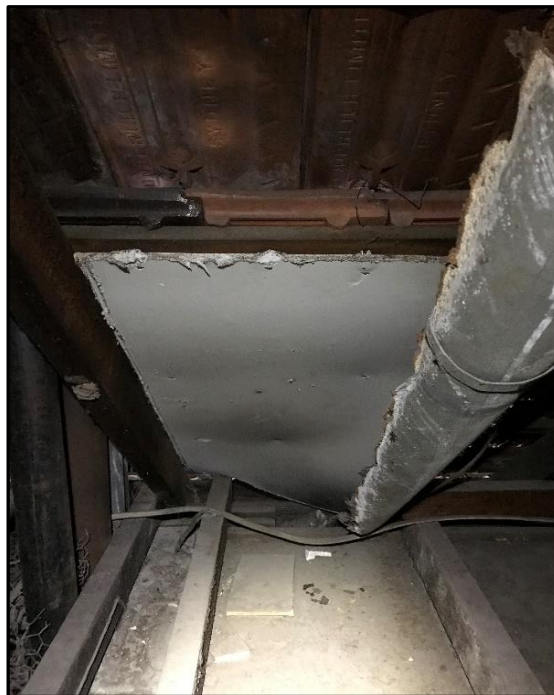
Photograph 2: 151 Kurraba Road, roof cavity, northern side of cavity, western end, low-density and/or weathered fibre board, asbestos detected by analysis.

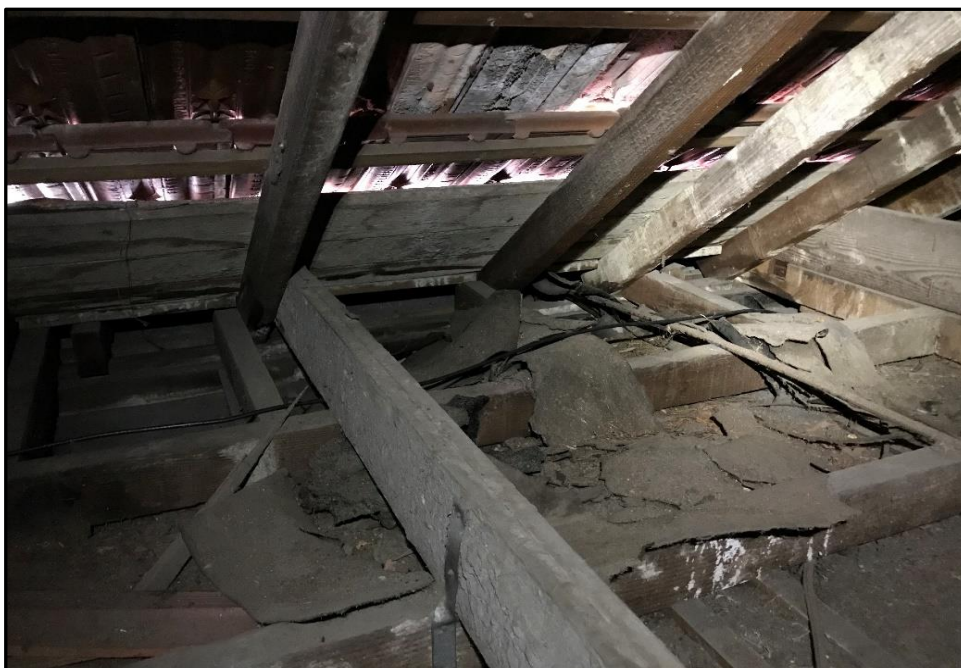
Photograph 3: 151 Kurraba Road, roof cavity, southeastern corner of cavity, bituminous lining debris, asbestos detected by analysis.

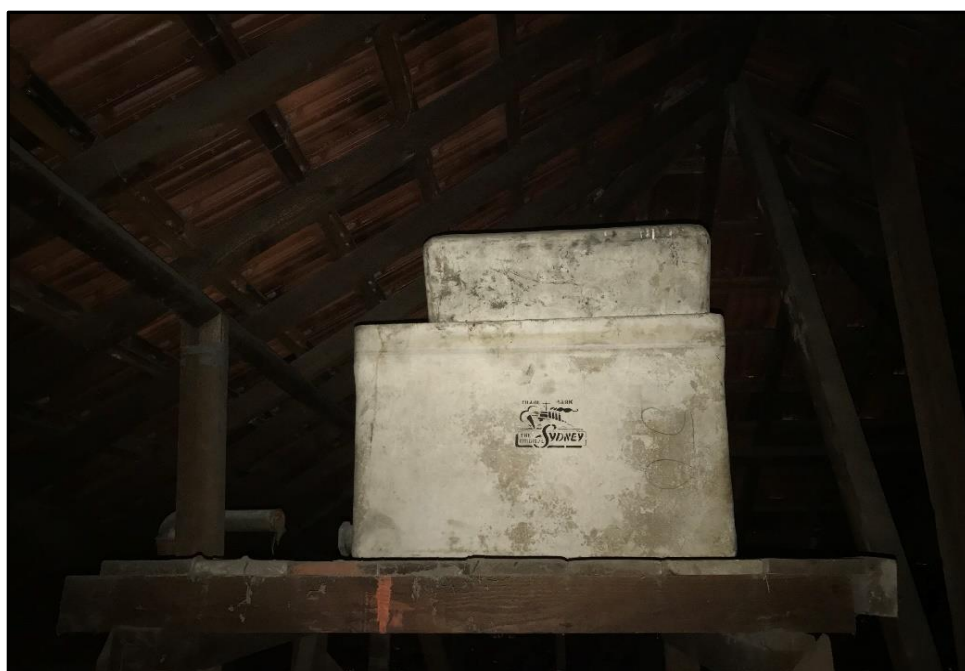
Photograph 4: 151 Kurraba Road, roof cavity, near centre of cavity, water tank and lid, fibre cement product, asbestos (assumed).

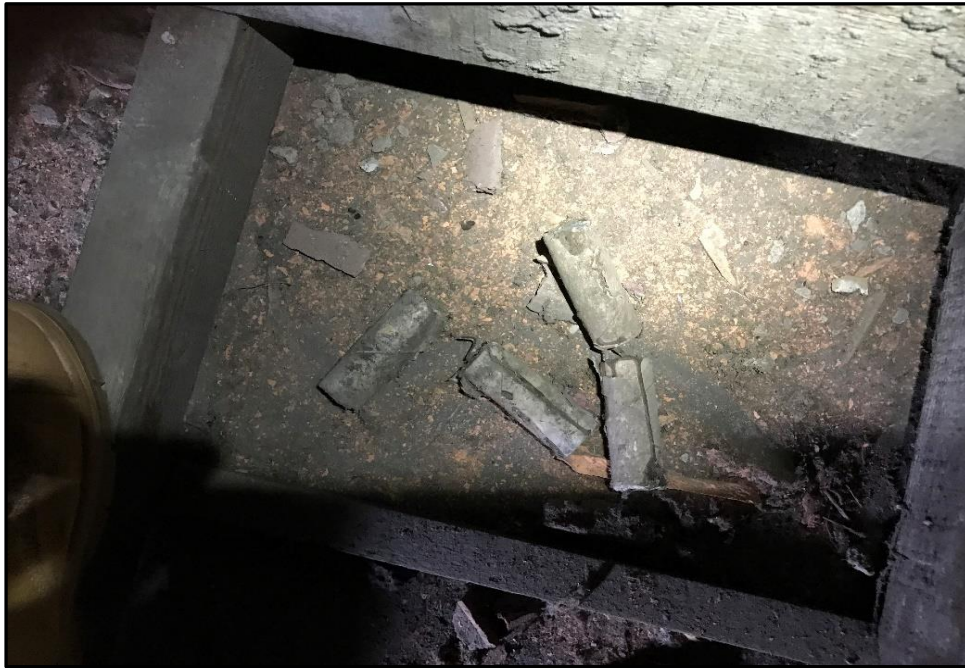
Photograph 5: 151 Kurraba Road, roof cavity, northwestern corner, cylindrical cannisters, no asbestos or PCB detected by analysis.

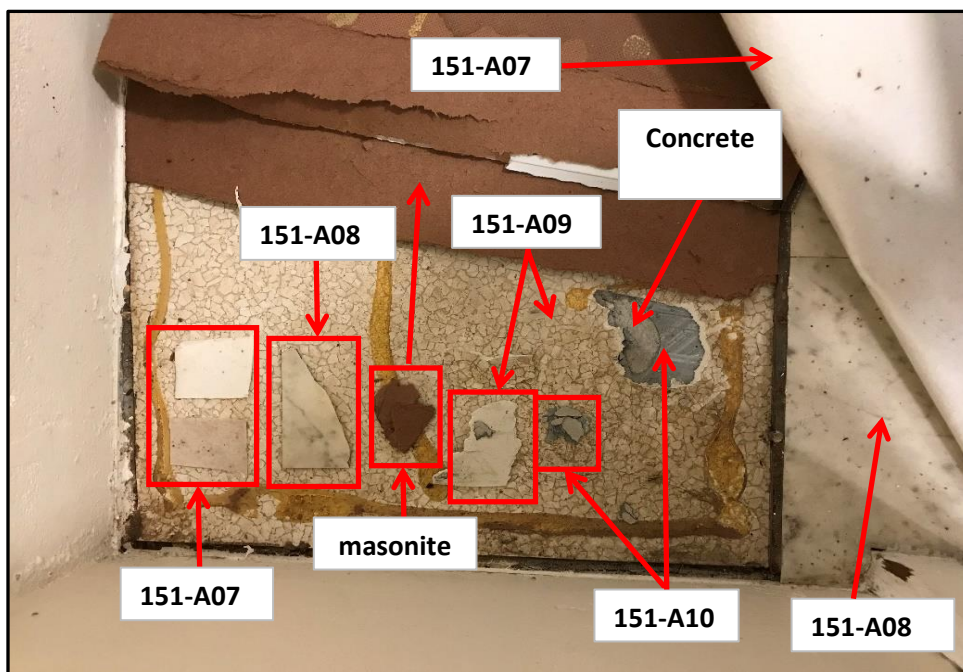
Photograph 6: 151 Kurraba Road, Unit 4, kitchen, flooring layers from top (151-A07) to bottom (151-A10) and apparent concrete slab.

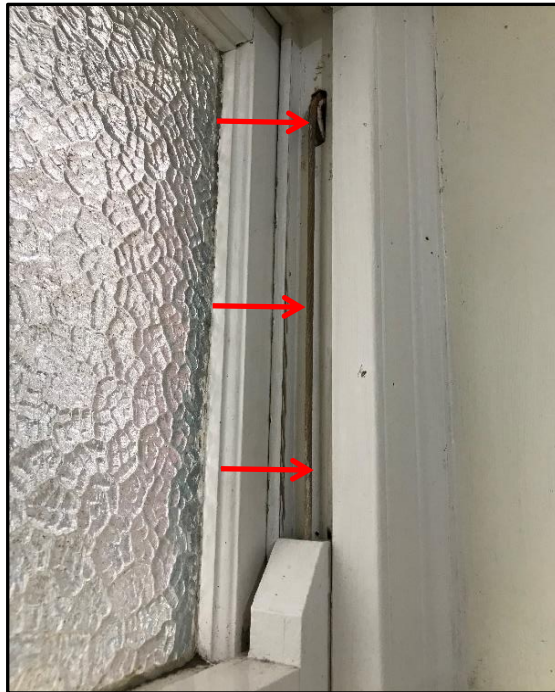
Photograph 7: 151 Kurraba Road, typical sash cord.

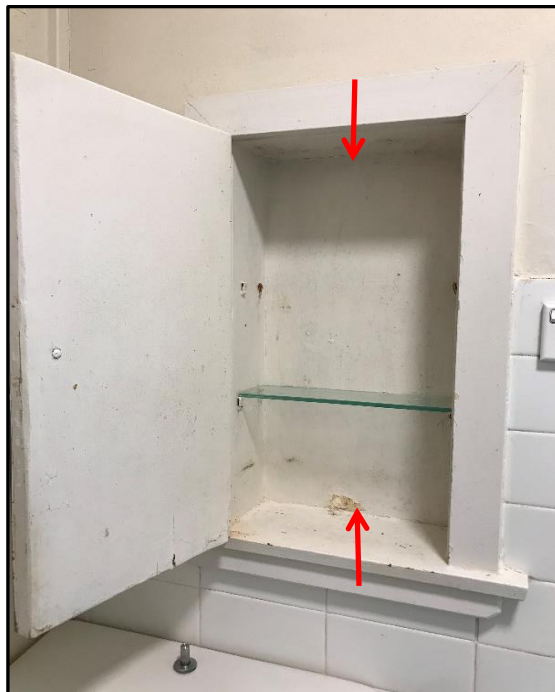
Photograph 8: 151 Kurraba Road, Unit 4, bathroom, mirror cabinet, rear lining, fibre cement sheeting, asbestos (assumed).

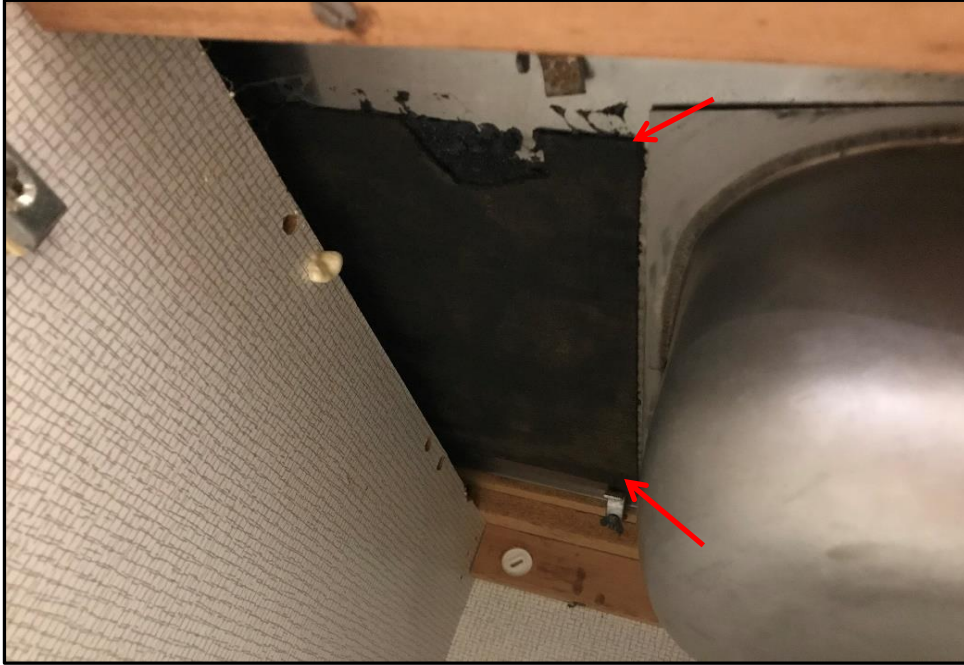
Photograph 9: 151 Kurraba Road, Unit 4, kitchen, underside of sink, bituminous lining, asbestos detected by analysis.

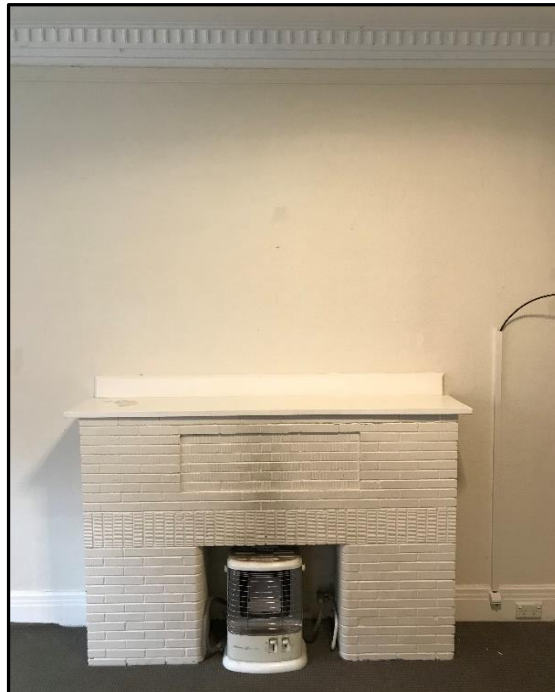
Photograph 10: 151 Kurraba Road, Unit 4, living room, chimney interior, inaccessible.

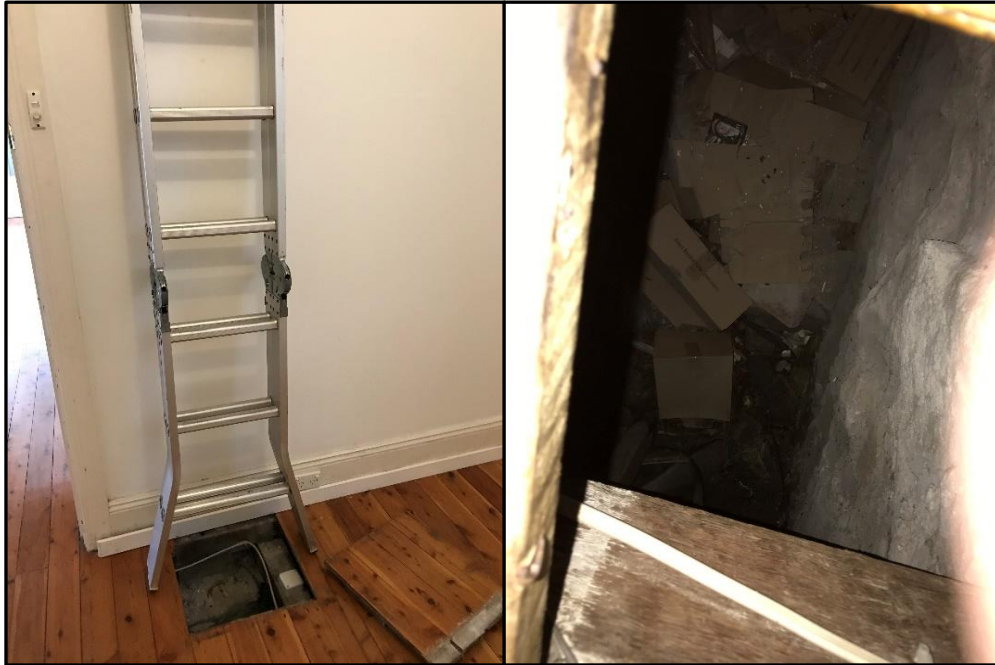
Photograph 11: 151 Kurraba Road, Unit 1, subfloor accessed from kitchen (per site plan), materials in general, inaccessible.

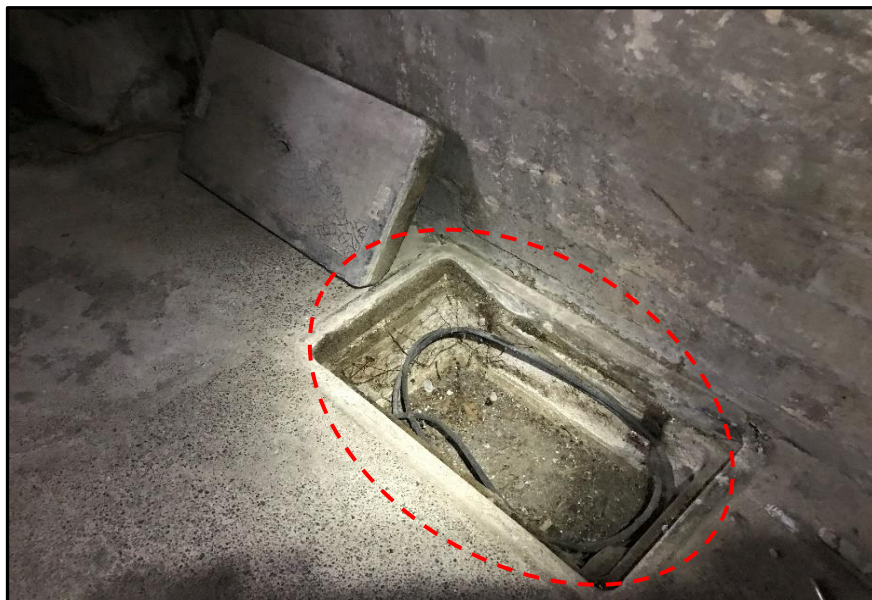
Photograph 12: 151 Kurraba Road, base or rear stairwell, emergency exit tunnel, northern end, ground, PMG pit, fibre cement product, asbestos detected by analysis.

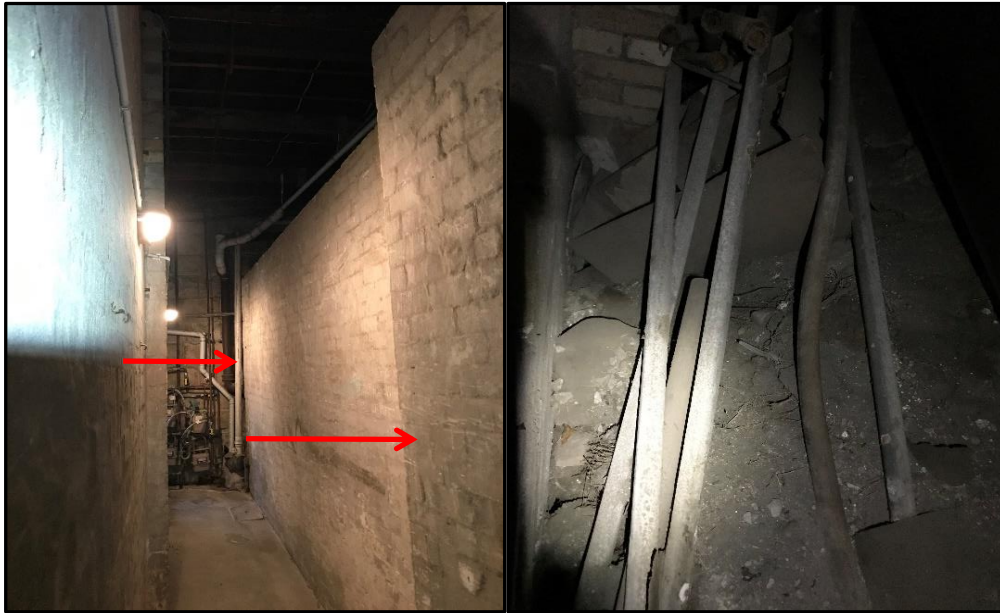
Photograph 13: 151 Kurraba Road, base or rear stairwell, emergency exit tunnel, behind retaining wall, waste/fill materials, inaccessible and may contain asbestos.

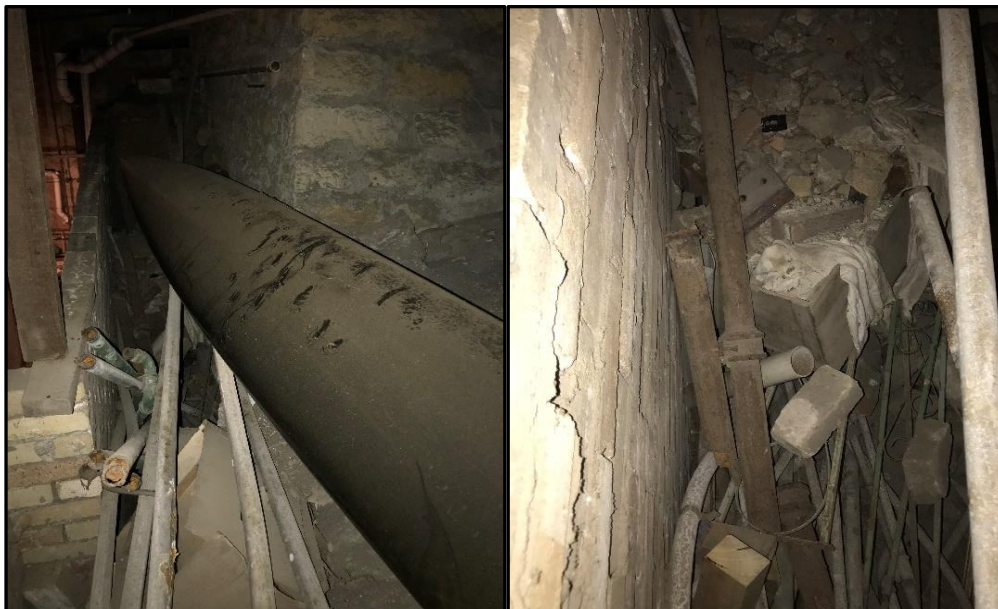
Photograph 14: 151 Kurraba Road, base or rear stairwell, emergency exit tunnel, behind retaining wall, waste/fill materials, inaccessible and may contain asbestos.

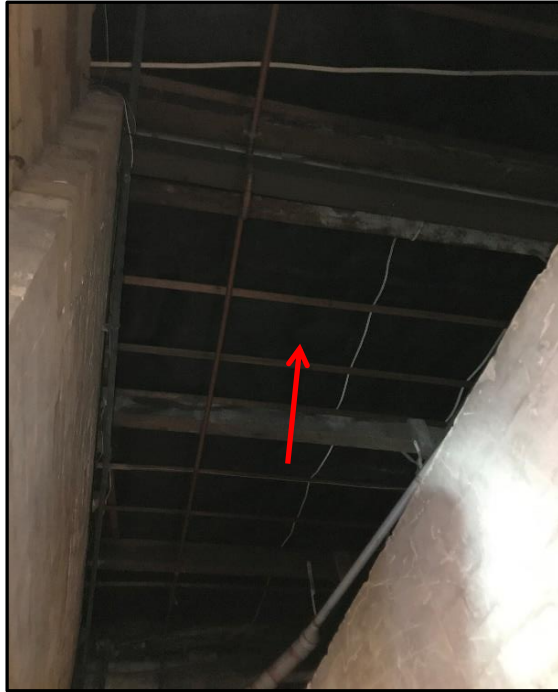
Photograph 15: 151 Kurraba Road, base or rear stairwell, emergency exit tunnel, ceiling, upper bituminous linings, no asbestos detected by analysis.

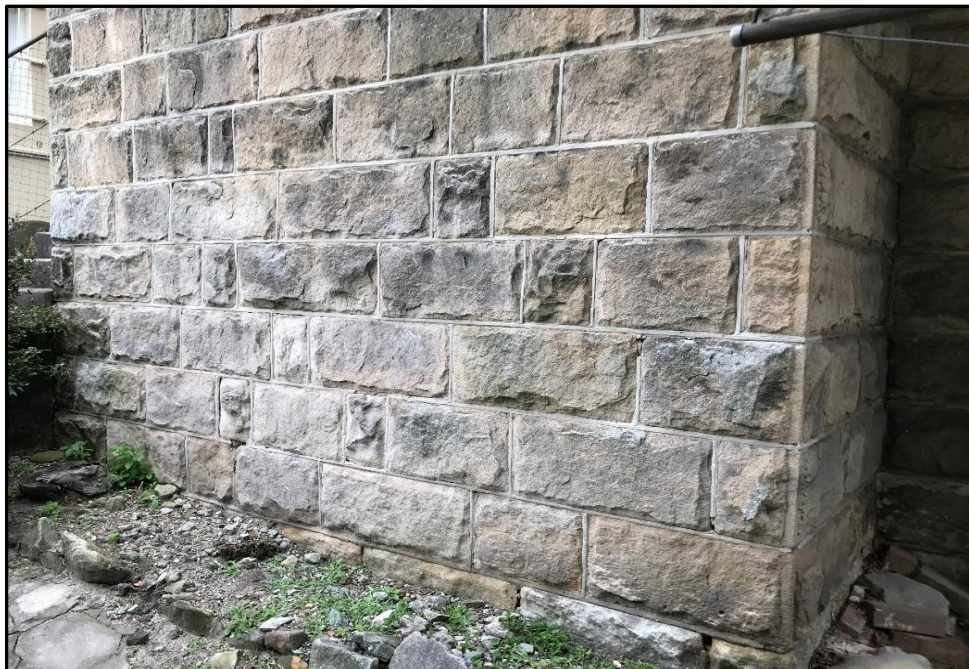
Photograph 16: 151 Kurraba Road, exterior, western façade, typical sandstone block wall, pointing, asbestos detected by analysis.

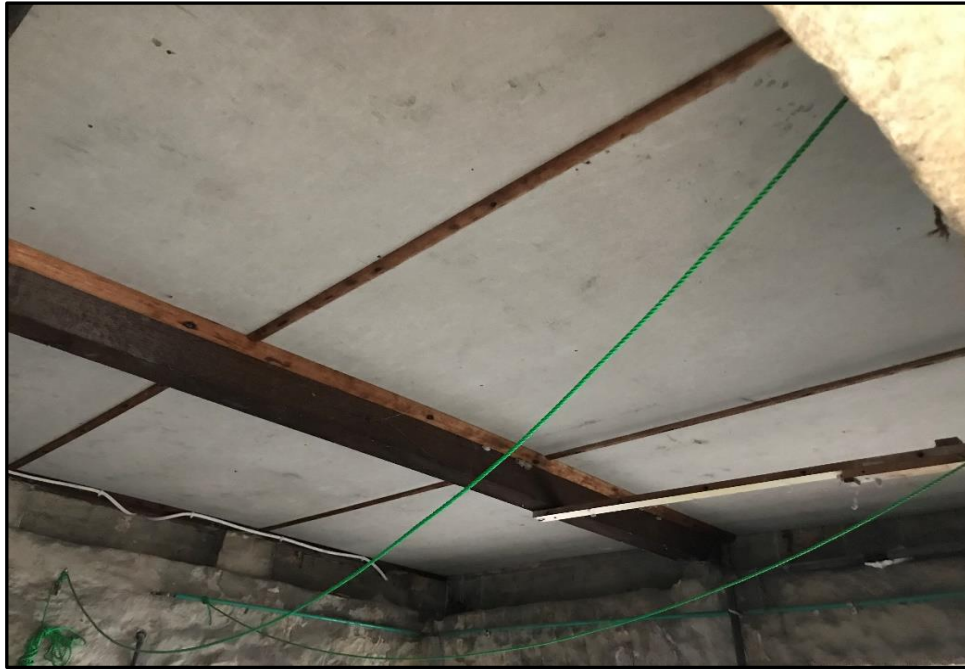
Photograph 17: 151 Kurraba Road, interior, communal laundry, ceiling, fibre cement sheeting, asbestos detected by analysis.
