Hazardous Building Materials (HBM) Survey

Proposed Residential Development  
147, 151 and 153 Kurraba Road  
Kurraba Point NSW

Prepared for  
Thirdi Group

Project 86447.06  
August 2020

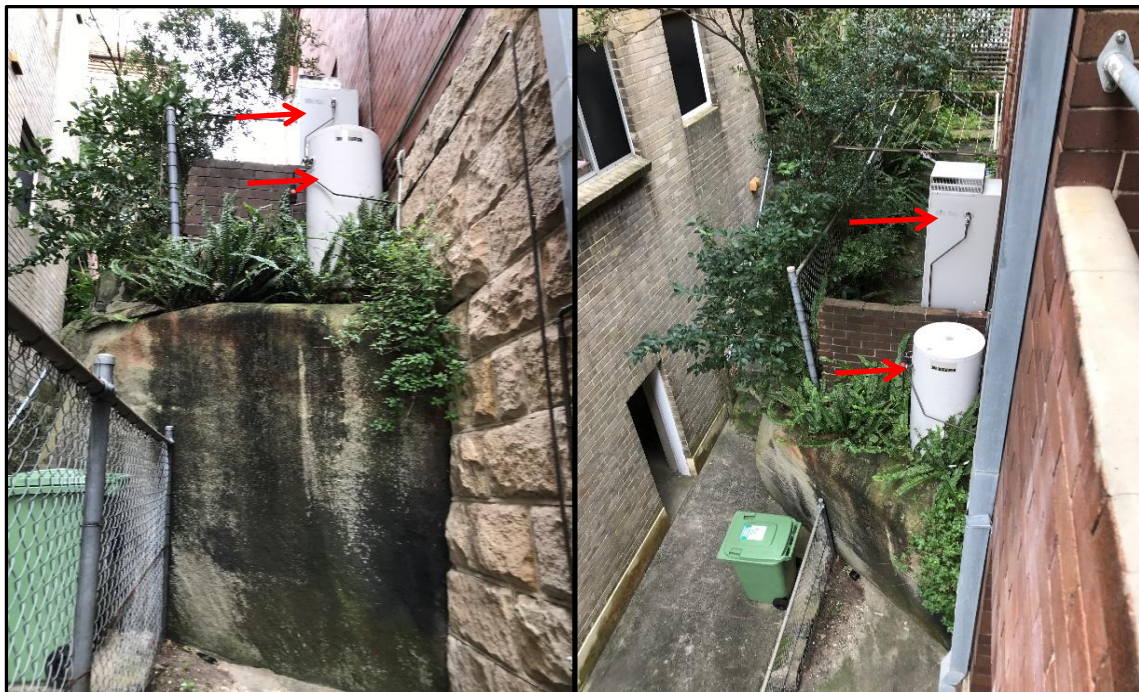
Photograph 18: 151 Kurraba Road, exterior, northern façade, hot water units (x2), internal insulation, suspected SMF or foam.

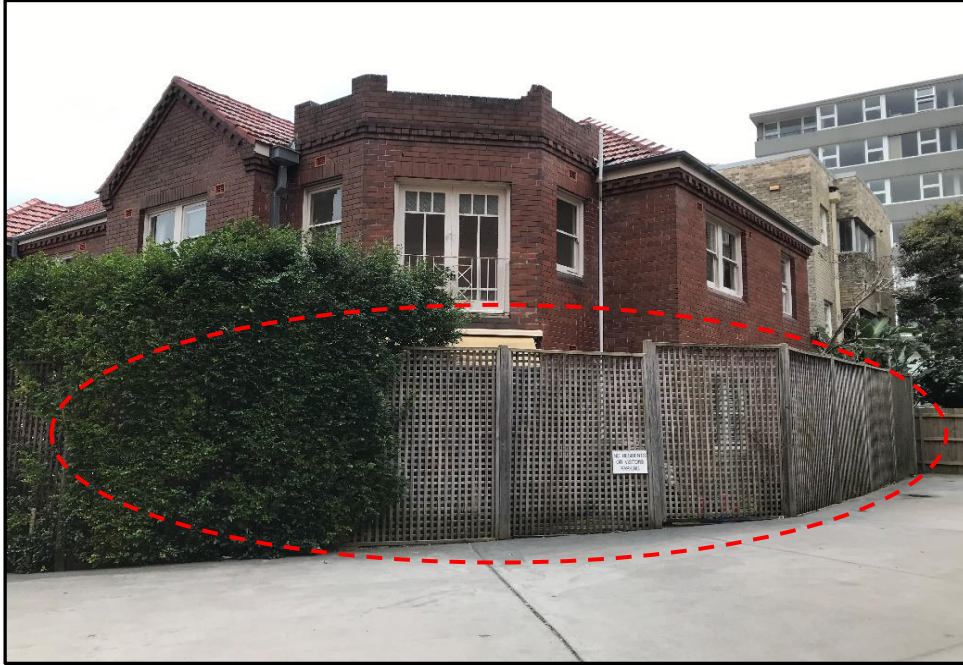
Photograph 19: 151 Kurraba Road, exterior, eastern facade and portion of northern façade, materials in general, inaccessible.

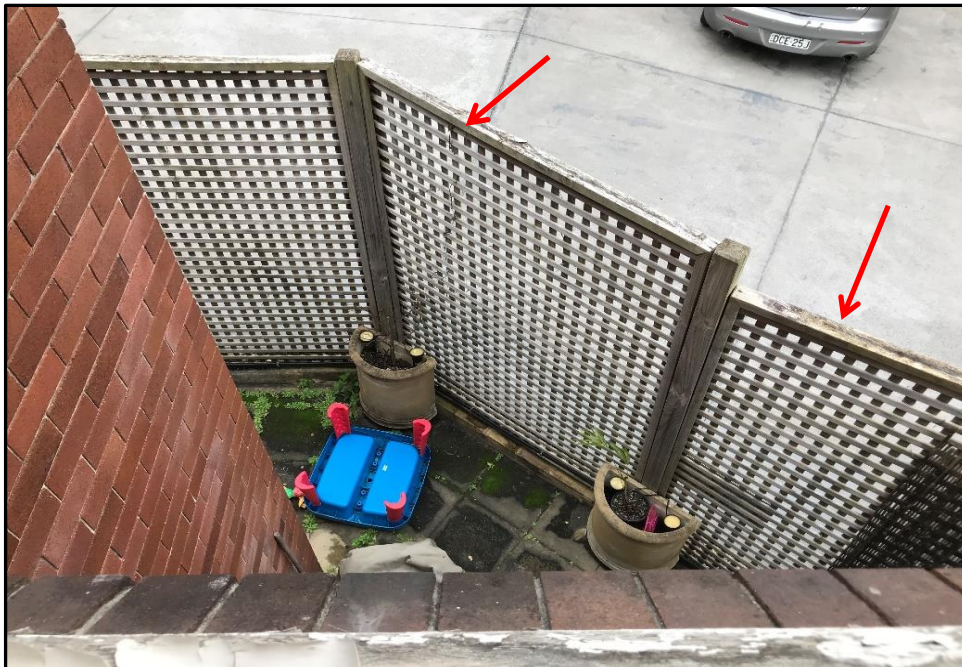
Photograph 20: 151 Kurraba Road, exterior, eastern facade and portion of northern façade, materials in general, inaccessible.

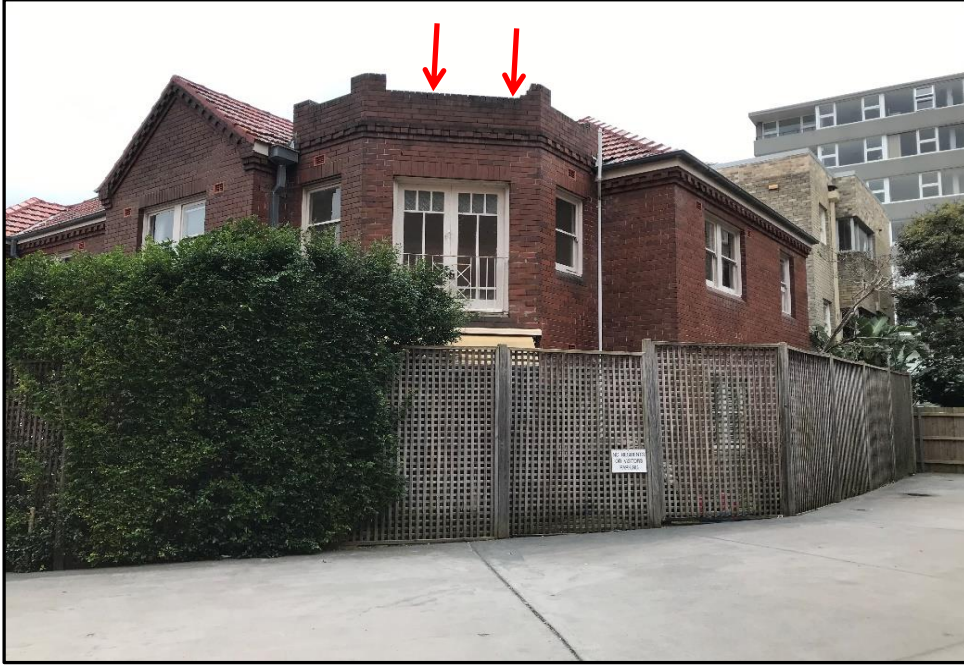
Photograph 21: 151 Kurraba Road, exterior, southwest corner building, parapet roof, waterproofing membrane(s), suspected asbestos.

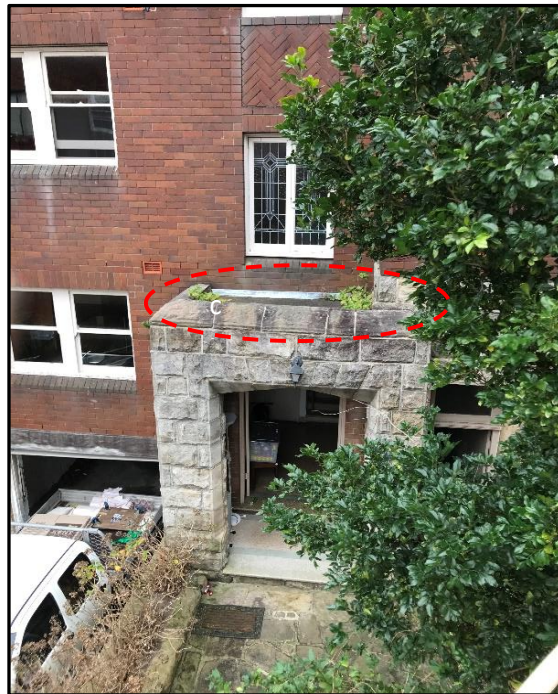
Photograph 22: 151 Kurraba Road, exterior, southern entrance alcove, roof, waterproofing membrane(s), suspected asbestos.

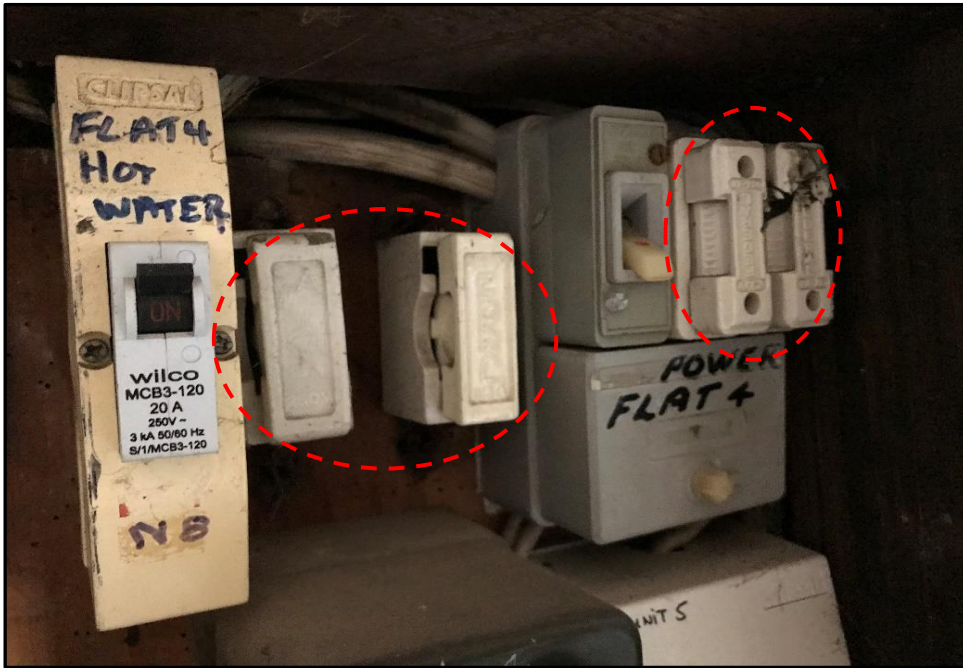
Photograph 23: 151 Kurraba Road, interior, main entrance, electrical panel at base of stairs, fuses, internal insulation, suspected asbestos.

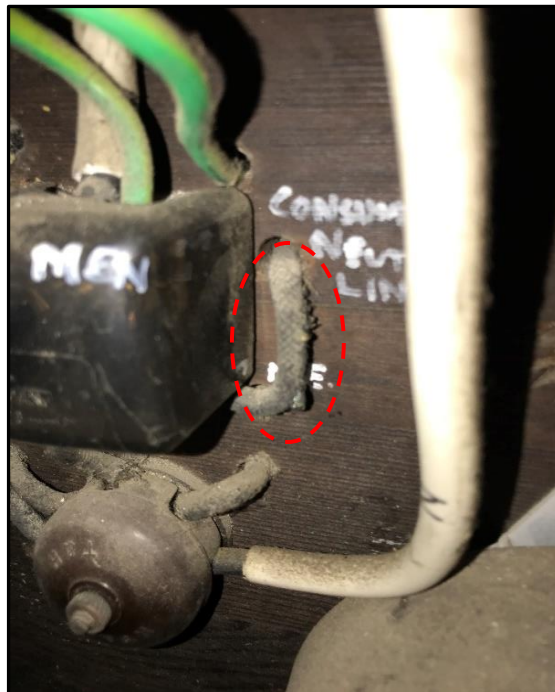
Photograph 24: 151 Kurraba Road, interior, main entrance, electrical panel at base of stairs, portion of wire insulation, suspected asbestos.

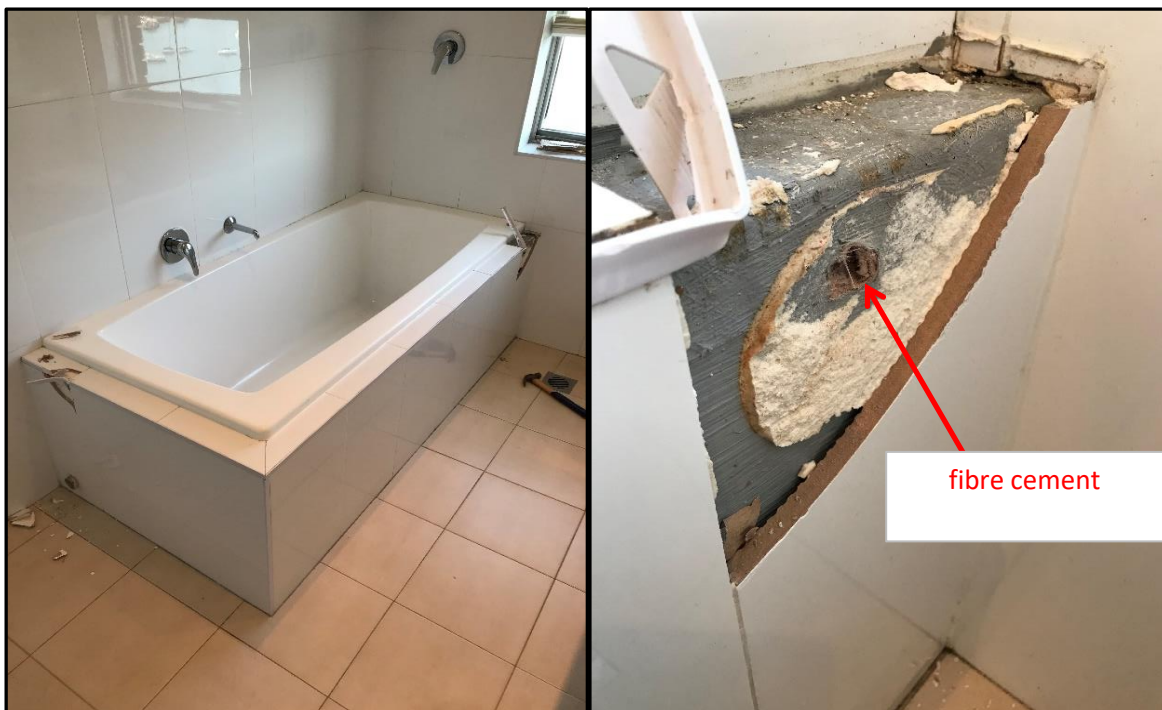
Photograph 2: 153 Kurraba Road, Unit 5, bathroom, below ceramic tiles to bathtub, grey waterproofing membrane and fibre cement sheeting, no asbestos detected by analysis

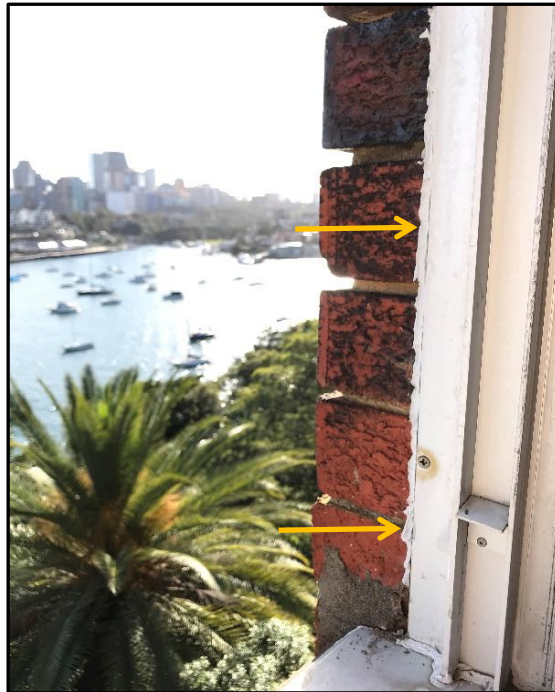
Photograph 5: 153 Kurraba Road, Unit 5, bedroom 2, exterior, between window frame and wall, putty/sealant, asbestos detected by analysis.

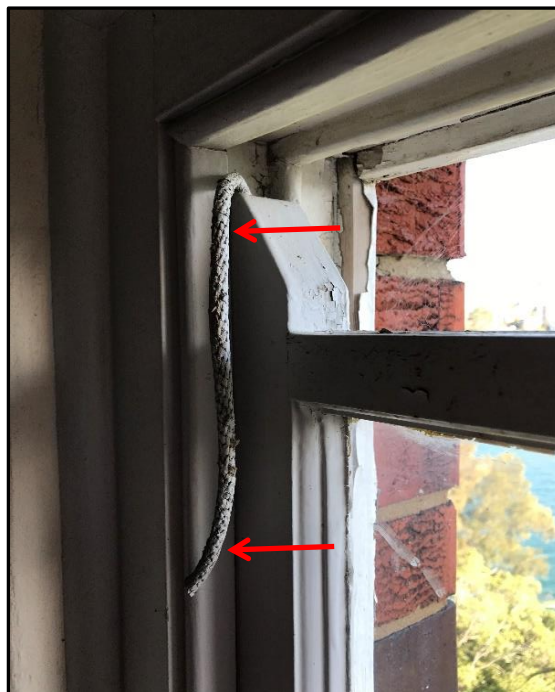
Photograph 6: 153 Kurraba Road, rear stairwell, typical sash window, sash cord, no asbestos detected by analysis.

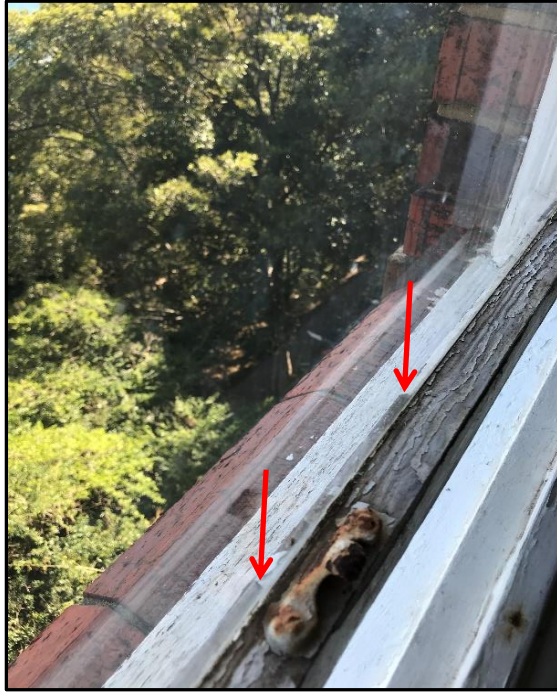
Photograph 7: 153 Kurraba Road, rear stairwell, typical sash window, glazing putty, no asbestos detected by analysis.

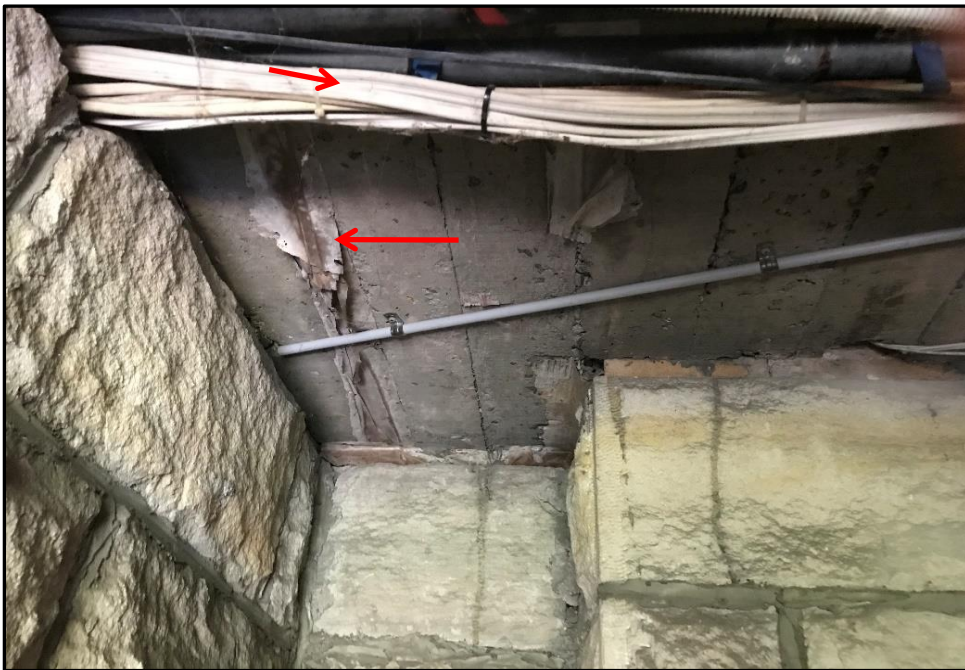
Photograph 8: 153 Kurraba Road, rear stairwell, base of stairwell, underside of concrete slab, paper/card lining, no asbestos detected by analysis.

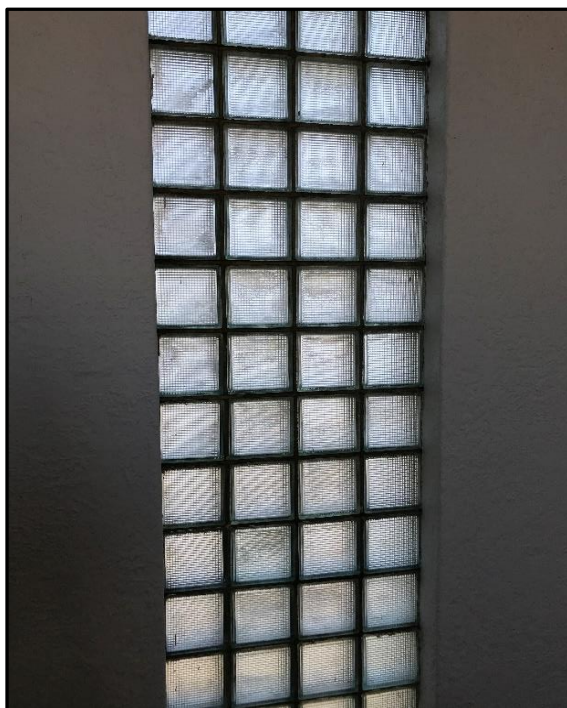
Photograph 9: 153 Kurraba Road, front stairwell, glass brick windowlight, pointing, no asbestos detected by analysis.

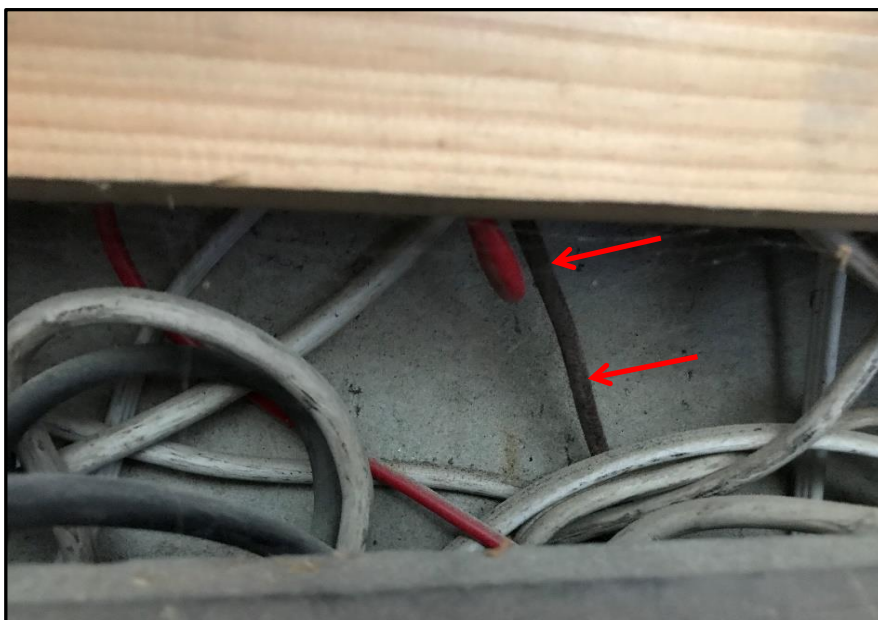
Photograph 10: 153 Kurraba Road, front stairwell, base of stairs, electrical cupboard, wire insulation, asbestos assumed.

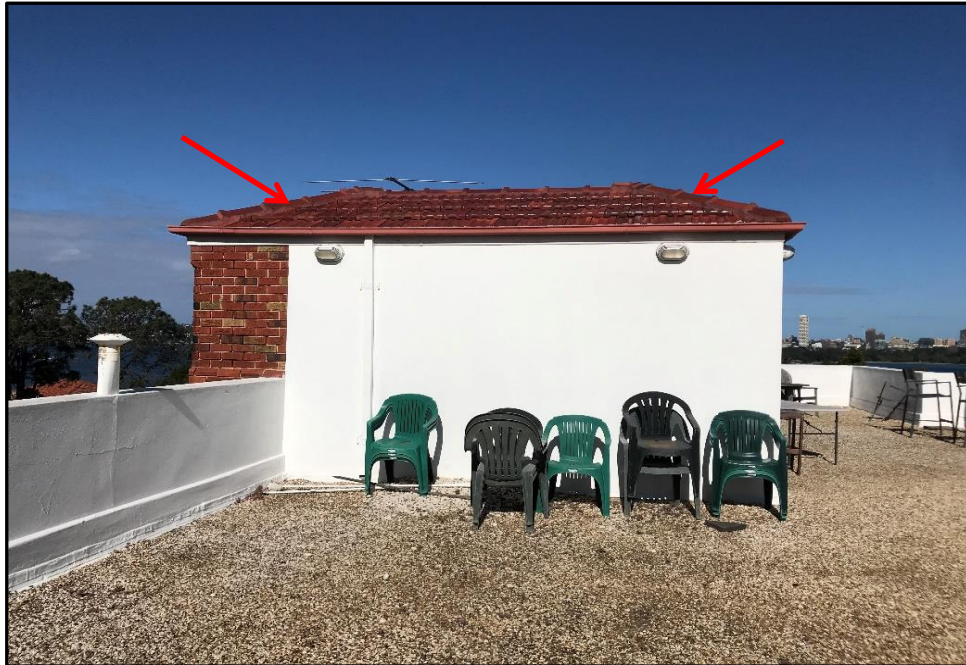
Photograph 11: 153 Kurraba Road, rooftop, ceiling cavity over stairwell, materials in general, inaccessible.

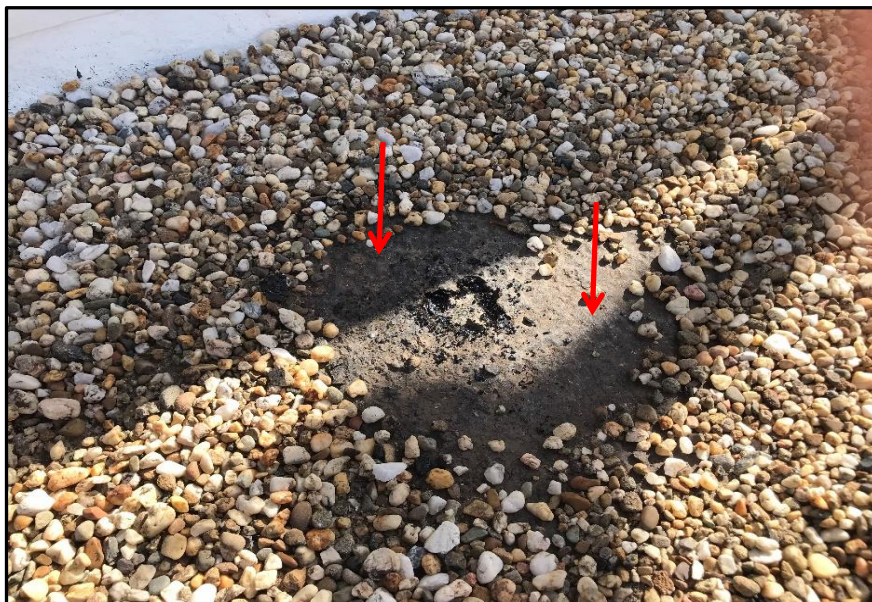
Photograph 12: 153 Kurraba Road, rooftop, throughout (below loose pebbles), bituminous lining, asbestos detected by analysis.

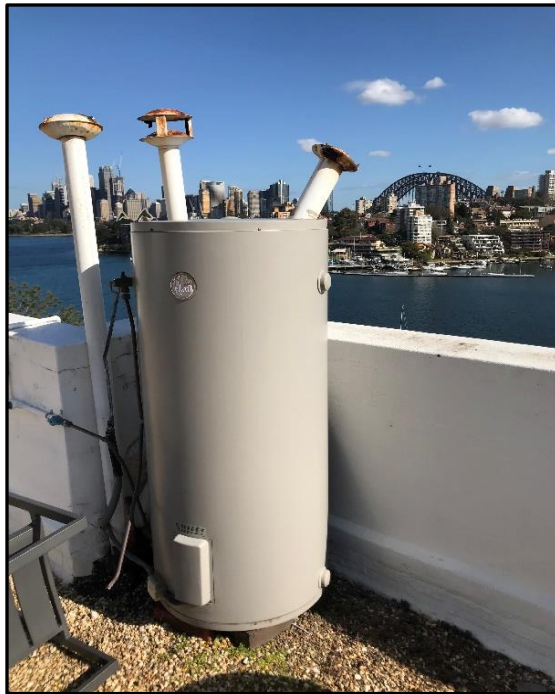
Photograph 13: 153 Kurraba Road, rooftop, hot water unit (manufactured 2015), internal insulation, SMF or foam.

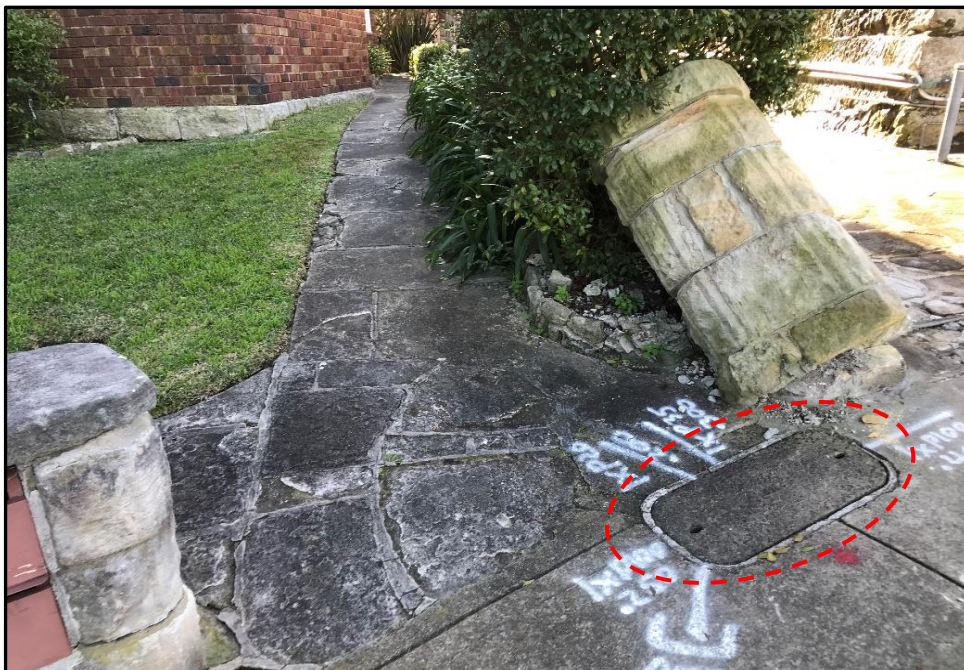
Photograph 14: 153 Kurraba Road, exterior, sidewalk adjacent Kurraba Road, fibrous pit, asbestos detected by analysis.

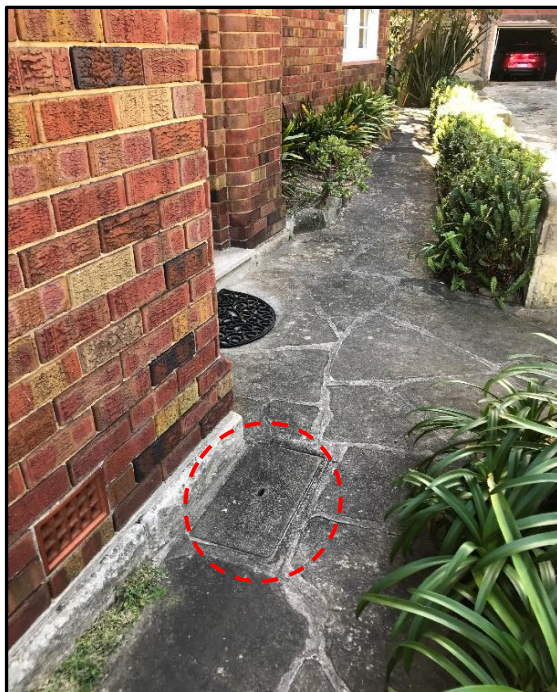
Photograph 15: 153 Kurraba Road, exterior, pavement adjacent main entrance to building, fibrous pit, asbestos detected by analysis.

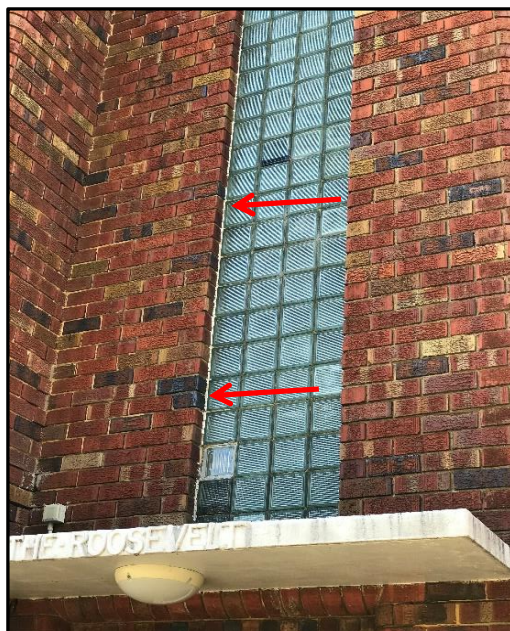
Photograph 16: 153 Kurraba Road, exterior, eastern façade, glass brick windowlight, putty/sealant, no asbestos detected by analysis.

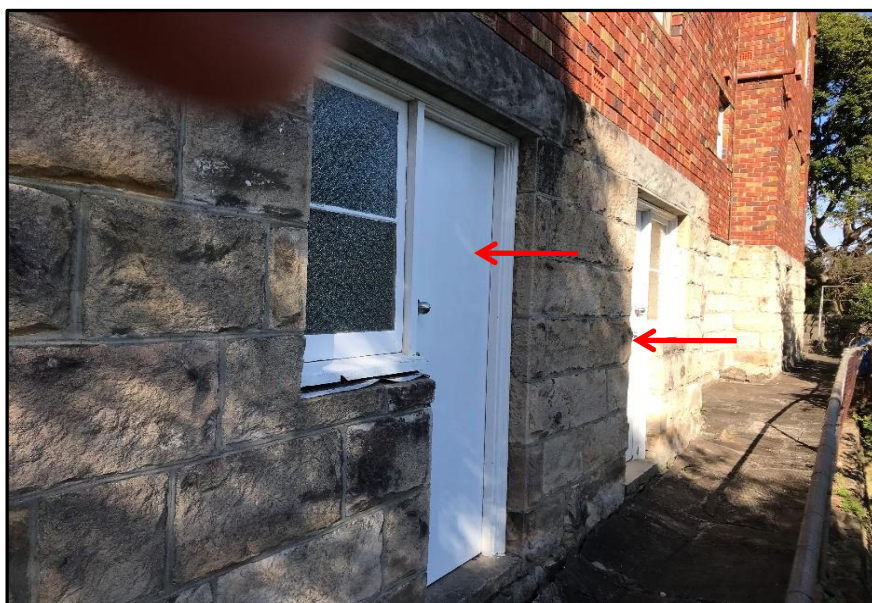
Photograph 17: 153 Kurraba Road, exterior, northern end of western façade, unmarked rooms x 2, inaccessible.

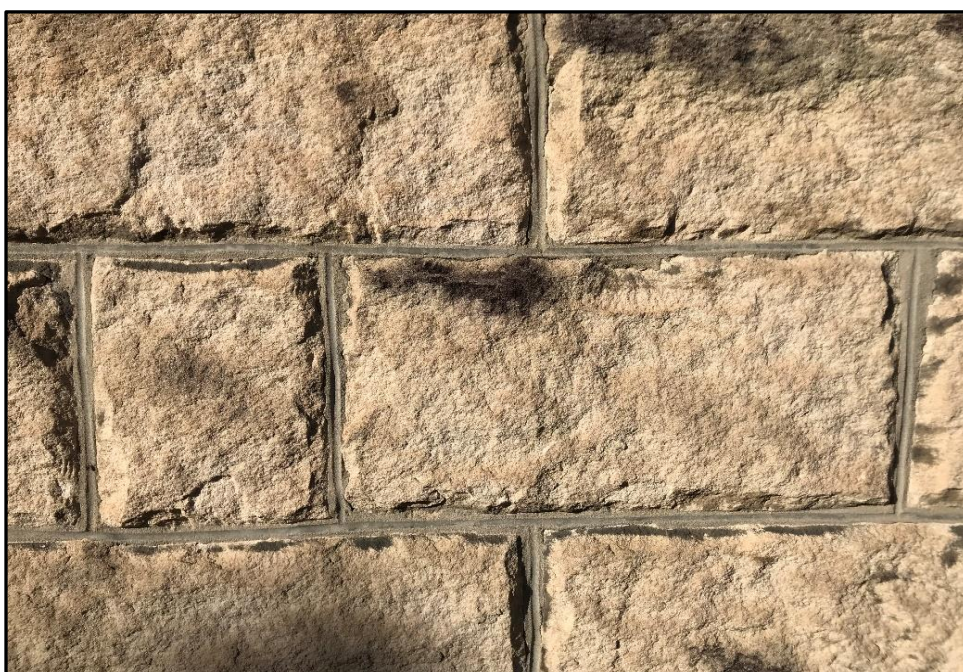
Photograph 18: 153 Kurraba Road, exterior, sandstone block walls, typical pointing, no asbestos detected by analysis (caution advised).

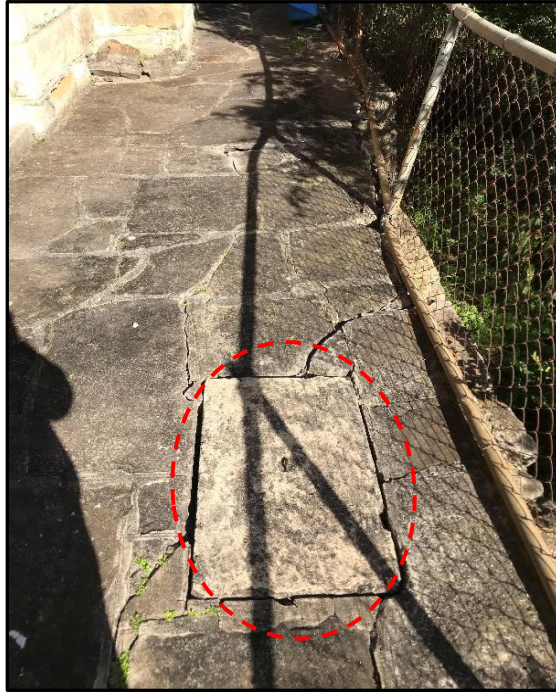
Photograph 19: 153 Kurraba Road, exterior, western side building, pavement, unidentified pit, inaccessible.

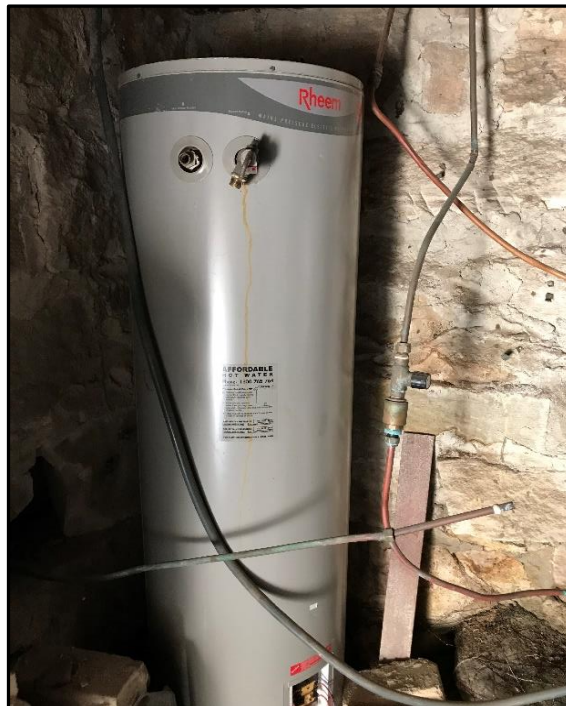
Photograph 20: 153 Kurraba Road, exterior, subfloor, several hot water units (circa 1997 to 2000's), bulk internal insulation, SMF or foam.

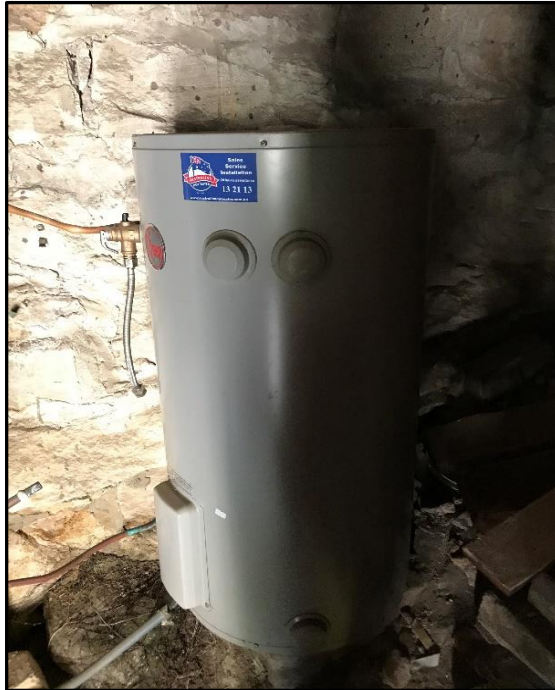
Photograph 21: 153 Kurraba Road, exterior, subfloor, several hot water units (circa 1997 to 2000's), bulk internal insulation, SMF or foam.

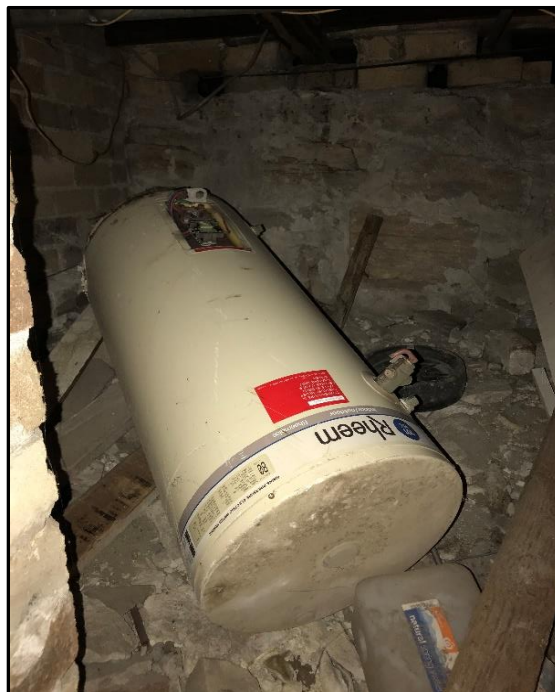
Photograph 22: 153 Kurraba Road, exterior, subfloor, several hot water units (circa 1997 to 2000's), bulk internal insulation, SMF or foam.

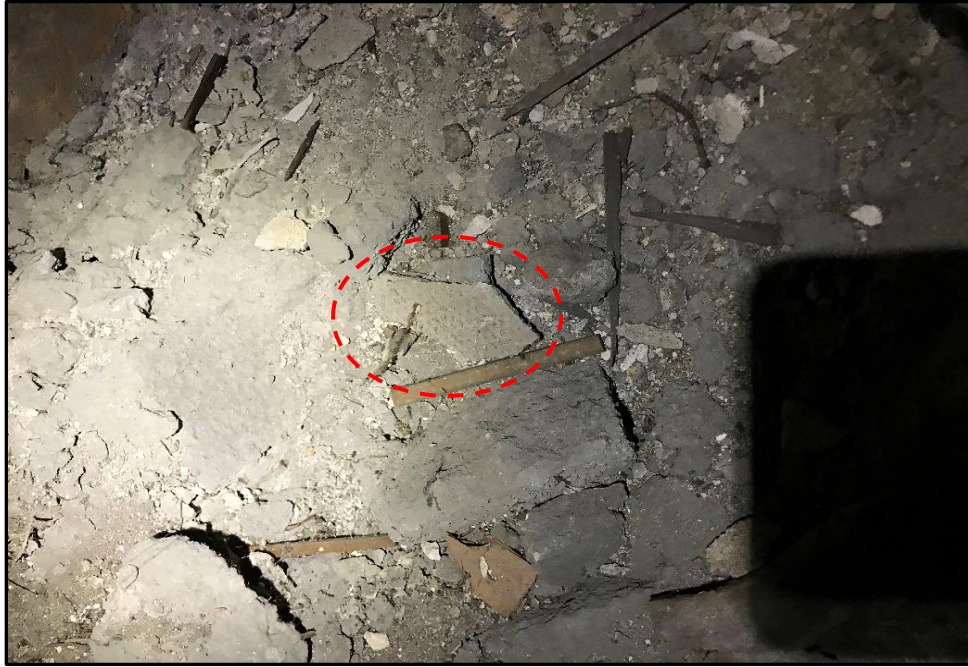
Photograph 23: 153 Kurraba Road, exterior, subfloor, ground surfaces, fibre cement debris, asbestos identified visually.
