Hazardous Building Materials (HBM) Survey

Proposed Residential Development  
147, 151 and 153 Kurraba Road  
Kurraba Point NSW

Prepared for  
Thirdi Group

Project 86447.06  
August 2020

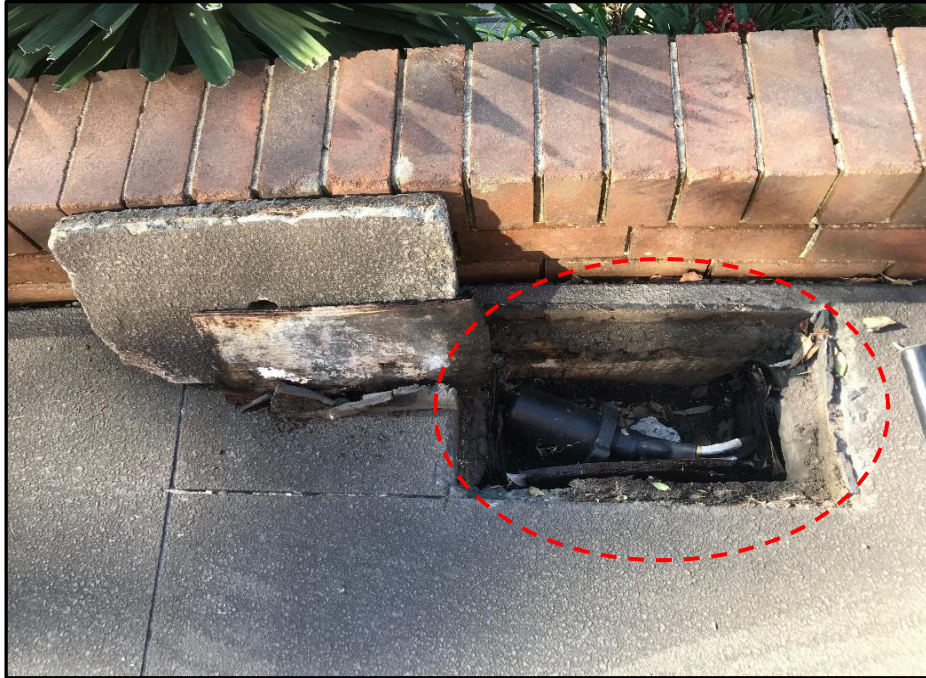
Photograph 1: 147 Kurraba Road, exterior, front driveway, PMG pit, fibre cement product, asbestos detected by analysis.

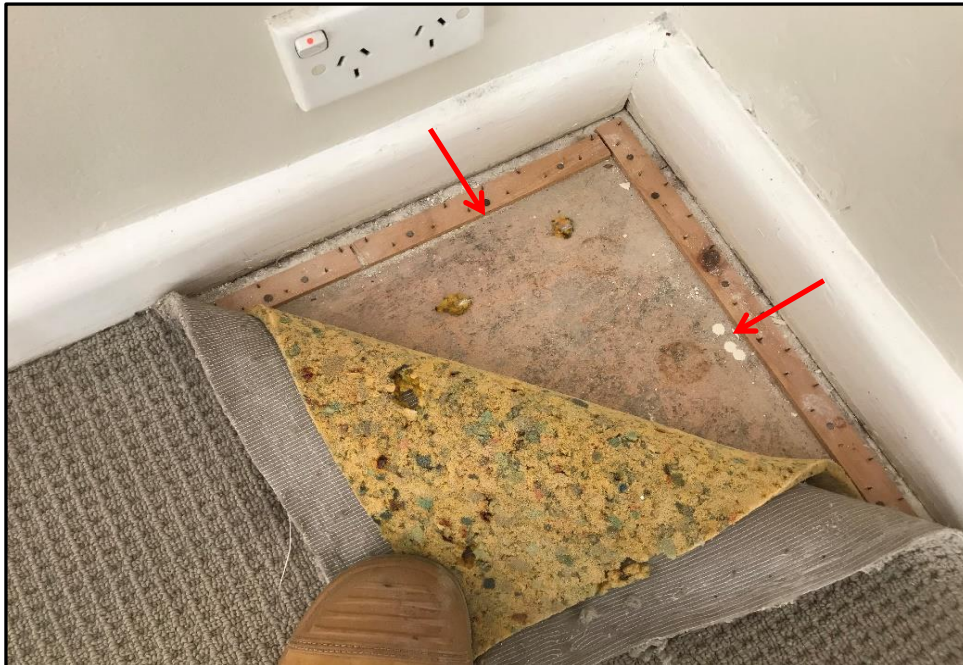
Photograph 1: 153 Kurraba Road, typical Unit, bedroom, floor below carpet, floor topping.
